Rainwater Management Plan: Ella Stream, Nott Brook, Throup Stream, and Wright Road Creek Watersheds

Final Report - Appendices
January 2012
KWL Project No. 2609.001-300

District of Sooke

Appendix A

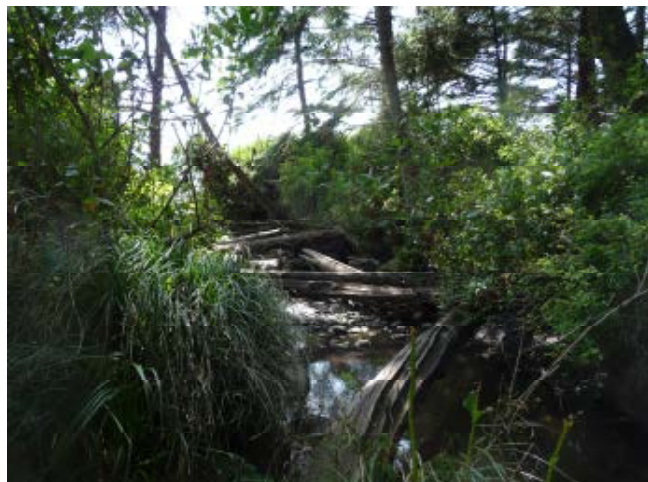
Rating: Proper Functioning Condition

Reach 1 is approximately 100m long and extends through a relatively undisturbed area from the outlet into Juan de Fuca to the tributary (Channel B) confluence.

The channel is a Rosgen “G6” channel, and is incised, deep, and overwide in places. The reach is very dynamic as it is influenced by tides and is exposed to Juan de Fuca Strait. Piles of large wood are present at the downstream end of this channel collected from high tides and deposited at the mouth. Erosion is evident, but is expected in this location due to its dynamic nature.

Rating: This reach is in Proper Functioning Condition as it displays the characteristics necessary to be able to withstand high stream flow events. However, some erosion is occurring in the upper portion of the reach.

Recommendations: While it is a dynamic reach as a result of its close proximity to the ocean, upstream management of rainwater will aid in reducing any excessive erosion that may occur.

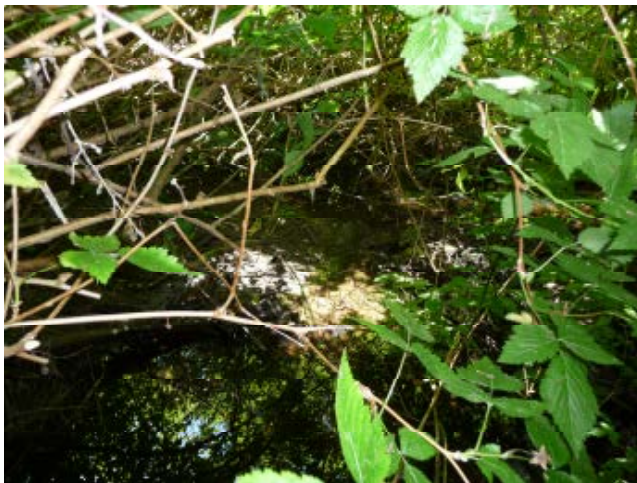
Rating: Proper Functioning Condition

Reach 2 is approximately 500m long and includes the area from the confluence with Channel B to the downstream edge of the wetland near West Coast Road. The channel is a Rosgen "C6" and is sinuous and able to access its expansive floodplain.

The riparian area is very wide in this reach, greater than 30m on either side and has a variety of vigorous vegetation. Vegetation species found in this reach include the following: Douglas fir (*Pseudotsuga menziesii*), Western red cedar (*Thuja plicata*), red alder (*Alnus rubra*), bigleaf maple (*Acer macrophyllum*), Indian plum (*Oemleria cerasiformis*), red elderberry (*Sambucus racemosa* ssp. *pubens*), salmonberry (*Rubus spectabilis*), Himalyan blackberry (*Rubus armeniacus*), sword fern (*Polystichum munitum*), lady fern (*Athyrium filix-femina*), common horsetail (*Equisetum arvense*), False lily-of-the-valley (*Maianthemum dilatatum*), skunk cabbage (*Lysichiton americanum*), sedges (*Carex* sp.), and various grasses.

Rating: Due to its unconstrained nature and expansive riparian, this reach is in Proper Functioning Condition.

Recommendations: In order to maintain this reach in its currently functional condition, ATV activity should be kept out of the riparian area. Other than the ATV management, the reach should be left as is, as it is able to respond to stresses it may experience. As development occurs in the upper watershed rainwater management should be implemented to maintain the health of the downstream sections.

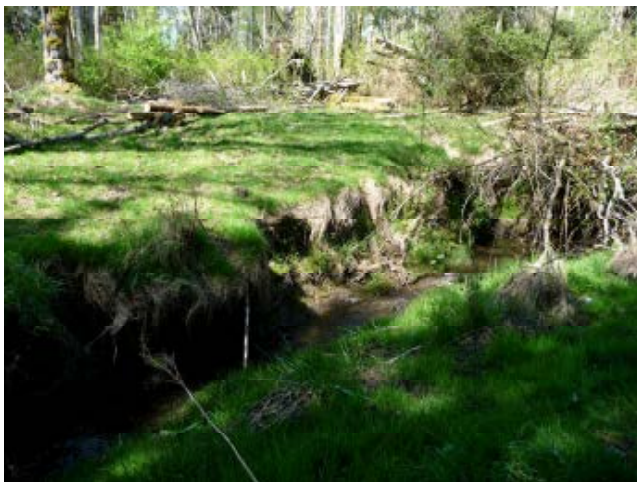
Rating: Nonfunctional

Reach 3 is approximately 890m, through primarily agricultural fields, from West Coast Road to Maple Avenue S. At the downstream end, two large culverts transport flows into a big wetland on T'Sou-Ke First Nation lands below West Coast Road. Upstream of the road, the stream flows through a small area of riparian vegetation before it is replaced by agricultural fields for the majority of the reach.

tree due to a wind storm) that could potentially lead to constriction of the flow through this channel in high flows. A small path is found adjacent to the creek edge and some piles of yard waste are present.

Recommendations: Historically, the stream in this location would likely have been a Rosgen “C4” channel. This Rosgen classification (“C4”) is the potential for this reach. However, for this reach to obtain its potential, the erosion must be reduced, the riparian zone widened, and the channel bottom raised.

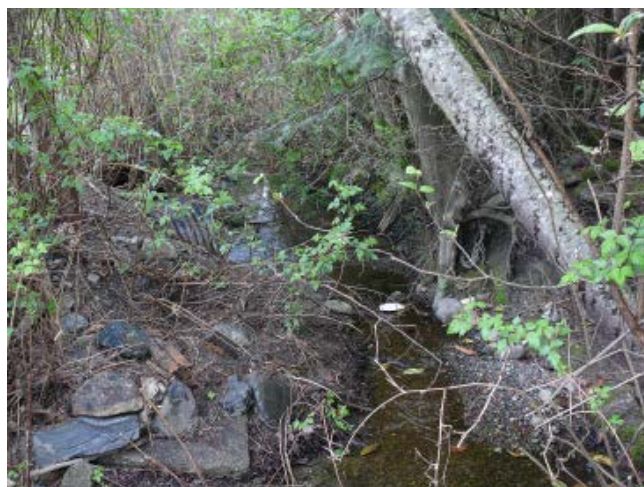
Rating: Functional-at-Risk (No Apparent Trend)

Reach 4 is approximately 390 m long extending from Sooke Centennial Park on Maple Avenue South to where Nott Brook crosses under Guardian Road through two large culverts.

Rating: Due to the downcut channel, steep slopes, and erosion, the channel is assessed to be Functional-at-Risk. However, there is no apparent trend of improvement or degradation for this reach. The channel is stable and has reached a form of equilibrium but is still showing signs of stress (i.e. erosion).

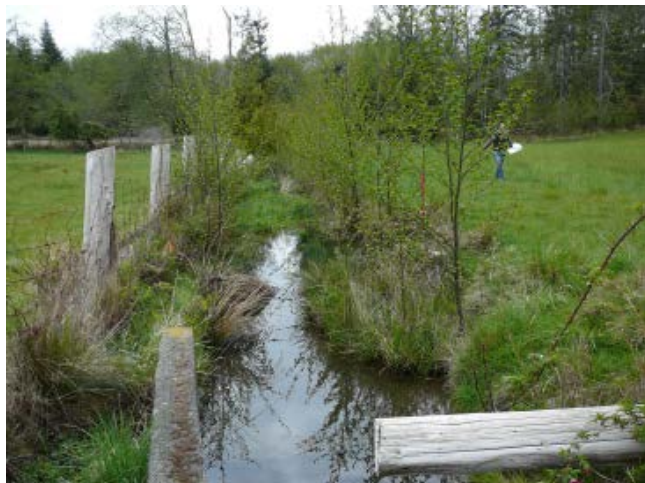
Rating: Proper Functioning Condition

Reach 5 is approximately 215 m and runs from where Nott Brook daylights upstream of the double culverts under Guardian Road and the trailer park properties to the private access road at 6865 Grant Road.

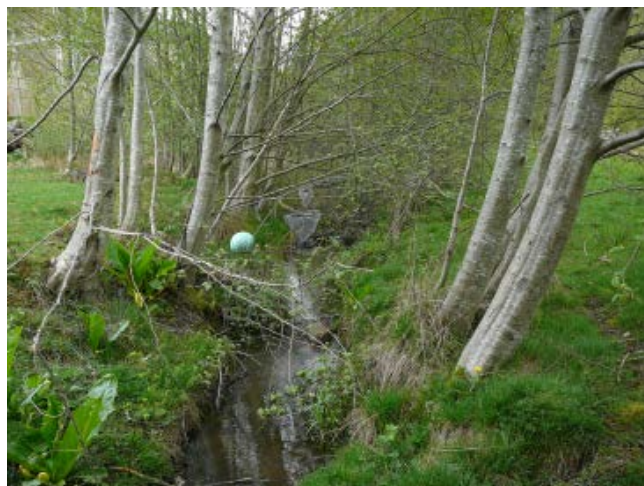
Rating: Functional-at-Risk (Downward Trend)

Reach 6 is approximately 250 m long and extends from the downstream boundary of 6865 Grant Road to where Nott Brook crosses Grant Road. This reach flows parallel to Grant Road behind a relatively new subdivision at 6865 Grant Road. A portion of the land adjacent to the south (left) bank has been set aside as park dedication and fenced.

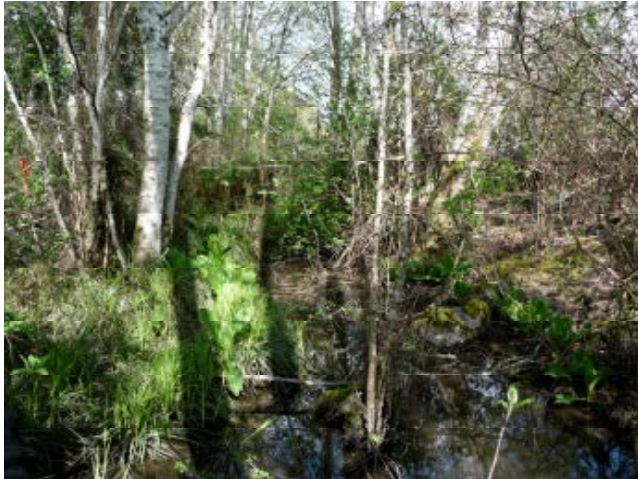
Rating: Proper Functioning Condition

Reach 7 is approximately 156 m in length and extends from Grant Road, upstream through 6790 Grant Road, to where a small tributary enters on the left (east) bank. The Rosgen channel type for this reach is a “C6” as a result of its gradient, sinuosity, and floodplain presence and accessibility. While the potential Rosgen channel type is also a “C6”, this reach is not at its full potential.

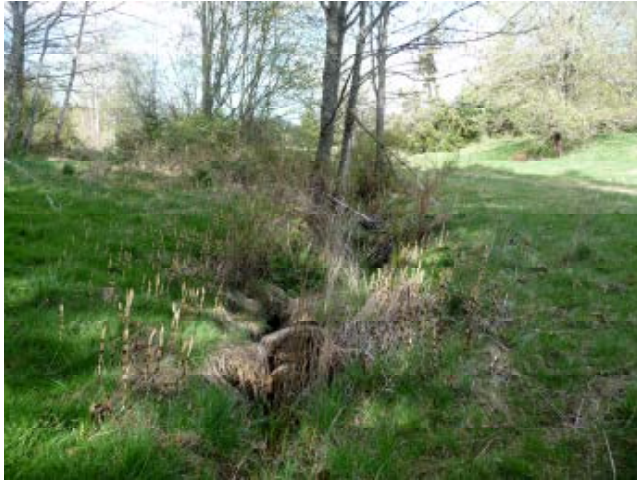
Rating: Functional-at-Risk (No Apparent Trend)

This reach is approximately 180 m long, extending from where the small tributary enters Nott Brook on the east side upstream to Otter Point Road. This reach is located on property that was a former golf course. As such, the channel has been heavily modified by ditching, straightening, and culverting in order to drain the property. What once would likely have been a Rosgen “C6” channel is presently a ditch although it has some remnant “C” characteristics.

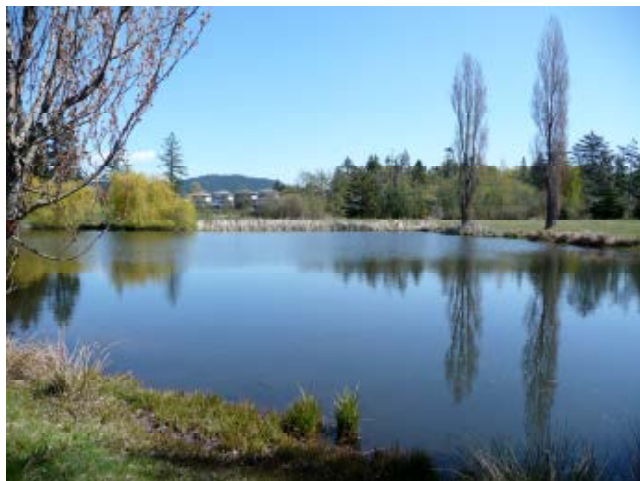
Rating: Proper Functioning Condition

Reach 9 of Nott Brook A consists of a pond and its inlet and outlet structures, this is a lentic (pond/wetland) site. This reach is located immediately upstream of Otter Point Road, near the Sooke Municipal Hall, on a former golf course.

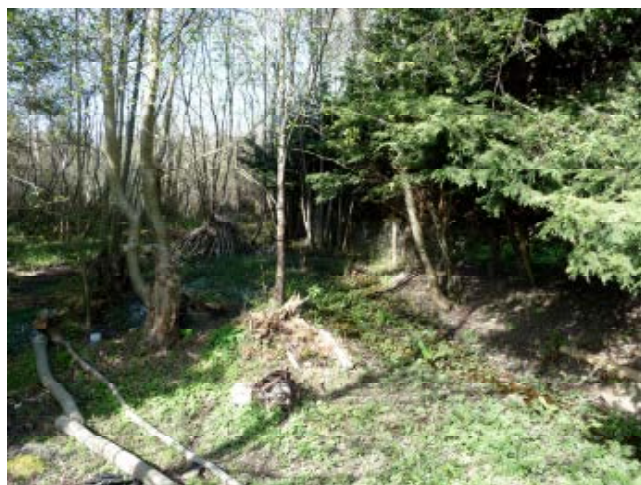
Rating: Proper Functioning Condition

Reach 11 is a small wetland covering approximately 0.19 hectares and extends along the west side of the former golf course property between 2164 and 2184 Townsend Road. The largest section of this wetland seems to be concentrated around 2170 Townsend Road.

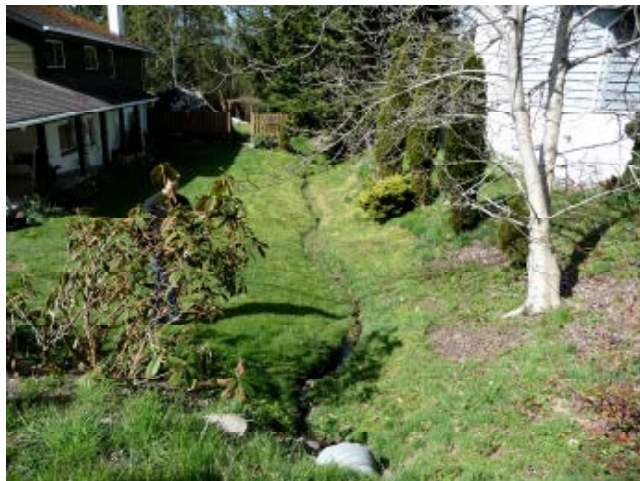
Rating: Nonfunctional

Reach 12 is approximately 50m and extends from the top of the wetland at 2170 Townsend Road to the Townsend Road culvert. This channel is a ditch with a small Rosgen “G” channel forming in its base. This rivulet forming within the ditch is a result of soft base materials being eroded from high velocity flows entering the small ditch from larger roadside ditches parallel to Townsend Road. As such, there more water moving through the channel than it is adapted for at its size.

Landowners abutting the channel say high and fast flows occur in this channel especially during storm events. These neighbours are concerned about back yard flooding and have noted an

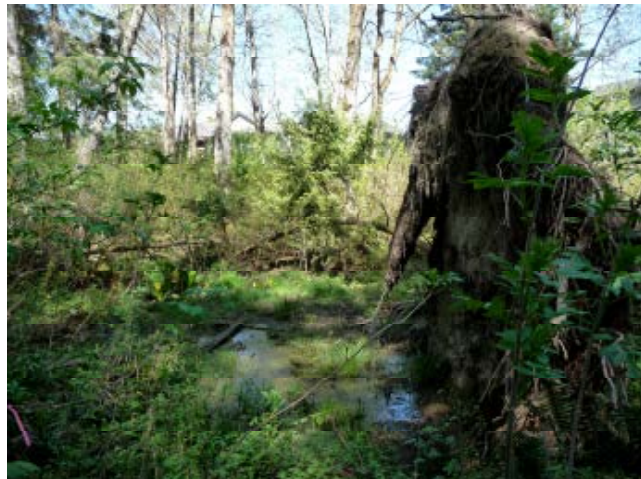
Rating: Proper Functioning Condition

Reach 13 of Nott Brook is the uppermost reach of the watershed. Near the eastern edge of 2191 Townsend Road is the watershed divide between Nott Brook Watershed and Throup Watershed.

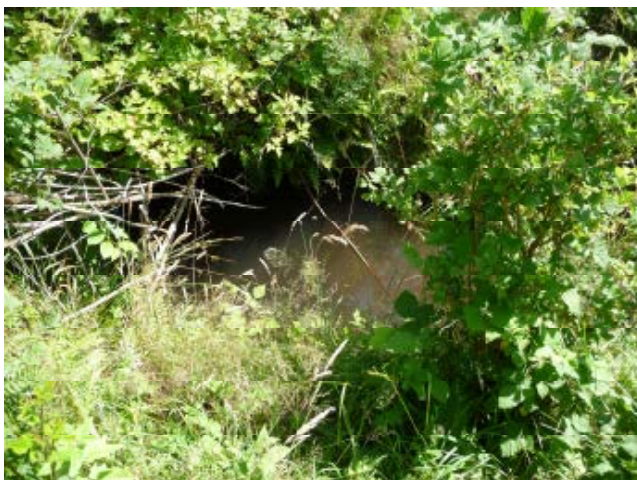
Rating: Nonfunctional

Reach 1 is approximately 400m long and includes the section of the channel from the tributary's confluence with the main Nott Brook channel upstream to West Coast Road. The channel in this location is a deep ditch. Historically, the landscape suggests that the channel here would have been a "C6" with accessible floodplain, sinuosity, and much shallower depth. The "C6" channel type is also representative of the potential for this reach. However, extensive restoration, including channel reconstruction would be required to reach this.

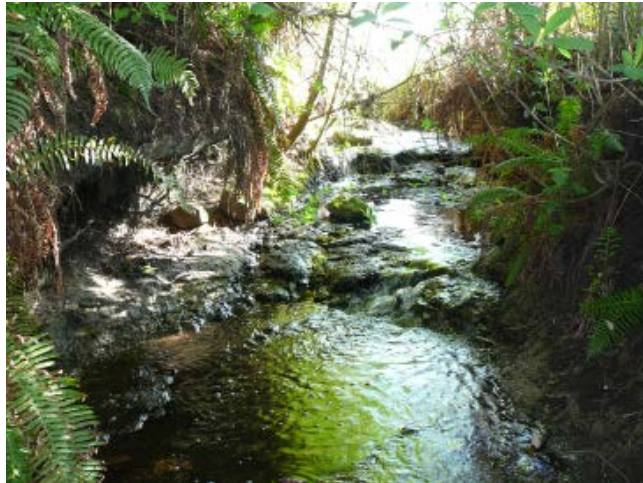
Rating: Nonfunctional

Reach 2 is approximately 160m long extending from the West Coast Road crossing to the upstream side of 7126 West Coast Road. The channel here has been excavated and as a result is deeper and wider than would be expected for the landscape setting. Currently, the stream is a Rosgen “G6” that is functioning as a ditch. The potential Rosgen channel type is a “C6” with a raised channel bottom, sinuosity, floodplain access, and a wider riparian-wetland area.

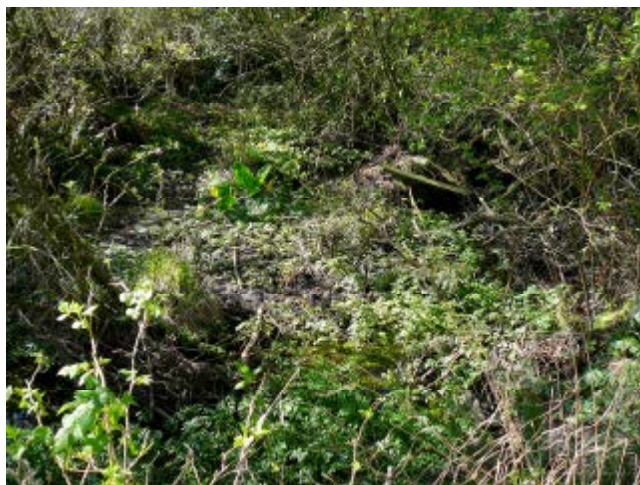
Rating: Proper Functioning Condition

Reach 3 extends for 100 m from 7126 to 7166 West Coast Road. The channel in this location is a Rosgen "E6", a narrow, shallow, grassy channel.

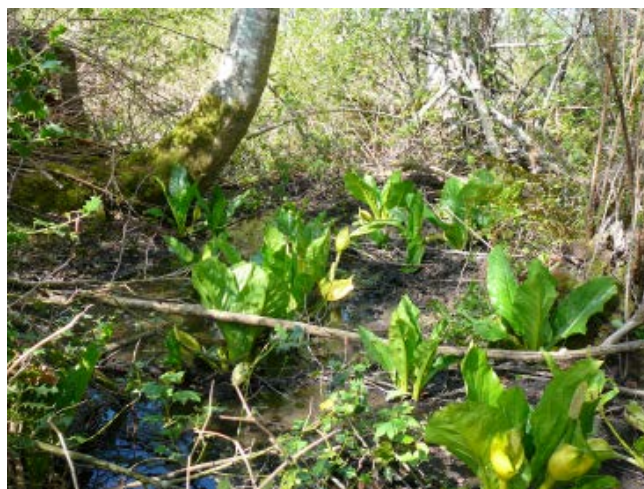
Rating: Proper Functioning Condition

Reach 4 extends from 7166 West Coast Road, near where a tributary enters from the west, behind residential and agricultural properties to a gravel road off Maple Avenue S. This reach is lentic (wetland) with standing water at, or near, the surface, and does not have a defined channel, except where one has been excavated at the top end of the reach.

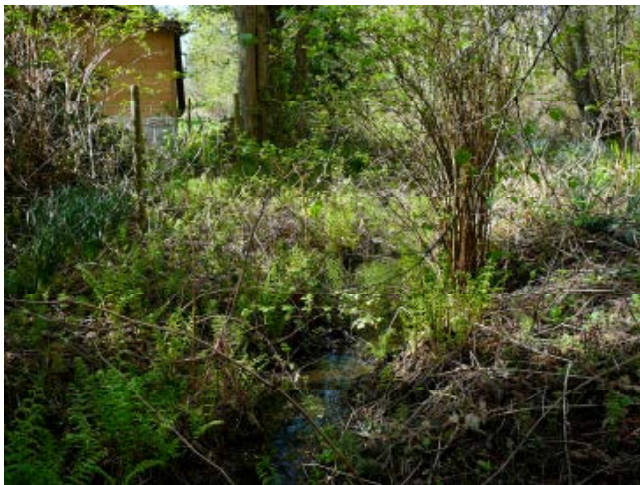
Rating: Proper Functioning Condition

Reach 5 is the wetland area on both sides of Maple Avenue S. Downstream of Maple Avenue S. a small channel, approximately 1.5m in width, has been excavated although it does not connect to the culvert that crosses under Maple Avenue S.

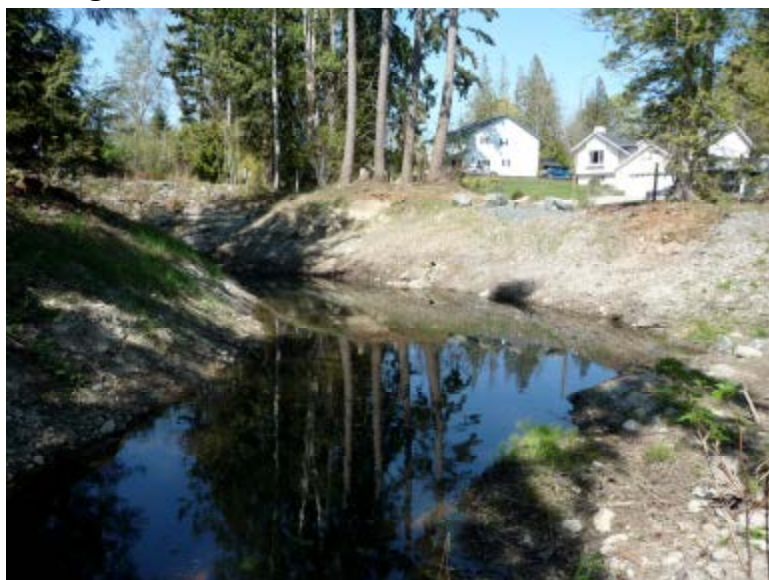
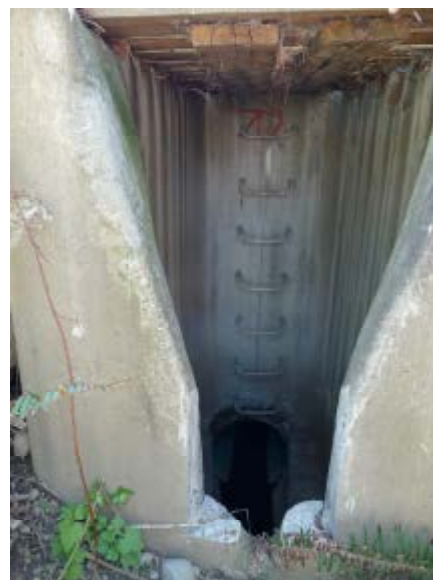
Rating: N/A

The stormwater detention pond at Maple Avenue North has recently been excavated and cleared of vegetation. Native aquatic and riparian species should be planted to allow filtration of runoff that is received by the pond. Additionally, the outlet structure from the pond has been modified and may present a safety risk, should anyone fall into the pond near the outlet during a storm event.

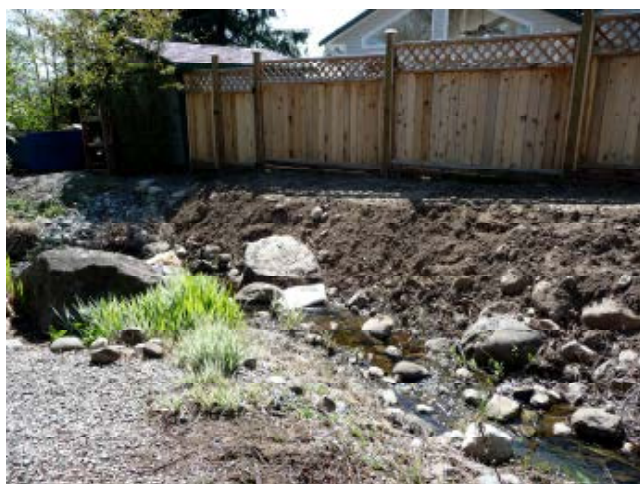
Rating: Nonfunctional

Reach 1 is approximately 175 m long and extends from 2134 Maple Avenue North to 2178 Maple Avenue North. This is an excavated channel that has been armoured for its entire length by rock. Therefore the Rosgen channel characteristic assessment cannot be applied. However, the potential Rosgen channel type is a “B3” due to the slope and character of the landscape setting. Reaching this potential will require restoration activities as discussed below.

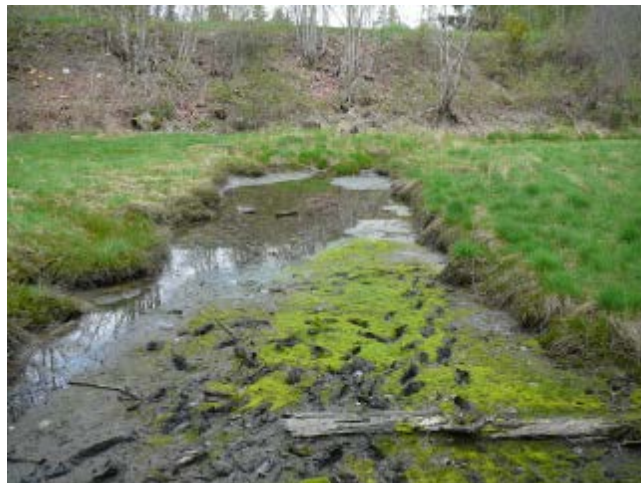
Rating: Proper Functioning Condition

Reach 1 of Throup Stream extends for approximately 60m from its outlet at Belvista Place upstream to Sooke Road. The creek is located in an agricultural field area and has multiple channels. Sections of this reach have been excavated for drainage, including the portion through the middle of the field, which is aligned with the culverts under the highway.

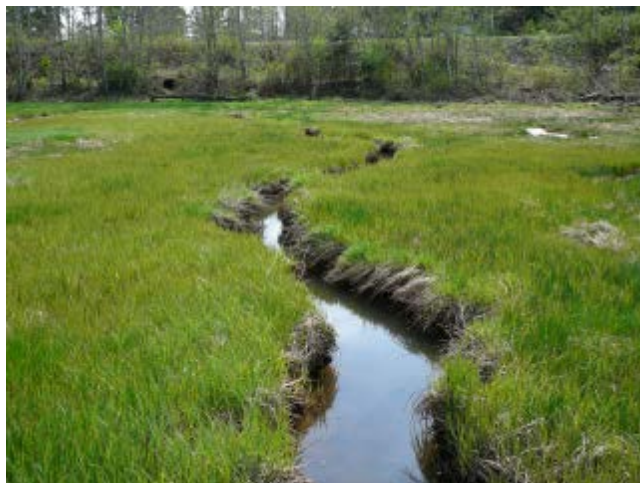
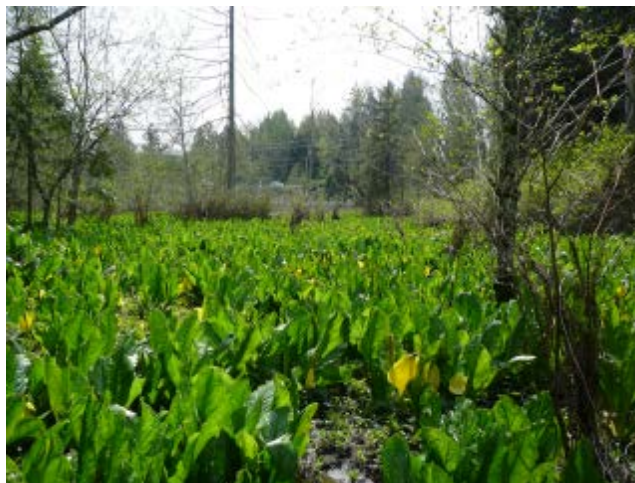
Rating: Proper Functioning Condition

Reach 2 extends for about 195m from Sooke Road upstream to the north end of the skunk cabbage wetland. This reach consists of multiple, narrow channels in a low gradient setting. As a result, the Rosgen channel type is an "E6". The potential channel type is also an "E6" and this reach is functioning in excellent condition.

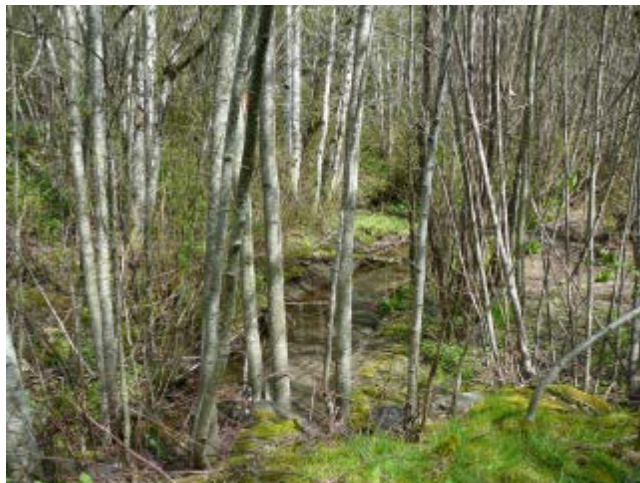
Rating: Proper Functioning Condition

Reach 3 is approximately 95m long from the north end of the skunk cabbage field to the culvert array near the baseball diamond. North of the skunk cabbage wetland, the channel widens and has one main channel instead of multiple channels. The channel is sinuous, the gradient is low, and the floodplain is accessible. As a result, the channel was determined to have a Rosgen "C5" classification.

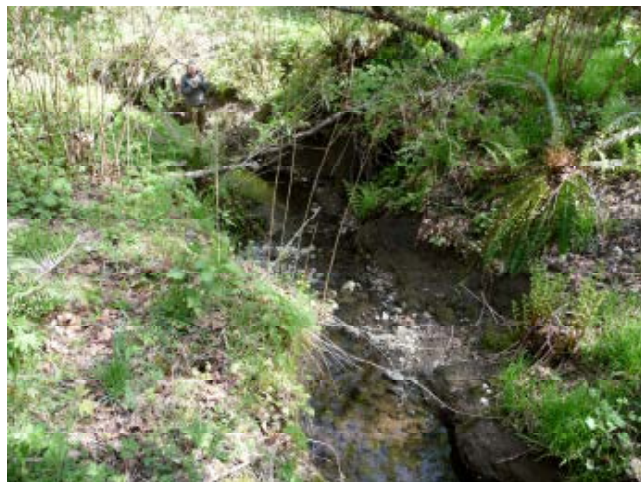
Rating: Functional-At-Risk with a downward trend

Reach 4 is approximately 280m long and extends upstream from the culvert near the ball diamond to 2190 Drennan St. Overall, the reach exhibits Rosgen "C4" channel characteristics; however, constraints are present, especially in the upper section of the reach. On the south bank, the slope is steep and a residential subdivision extends near to the top of the bank. On the north bank, a berm, likely constructed as part of historic land clearing activity, is reducing floodplain accessibility. Excessive erosion is occurring in the upper part of this reach (downcutting of the channel). The channel bottom is deepening and there is no floodplain access to dissipate erosive energy from high streamflow events. Adjacent to the channel at the downstream end is a large

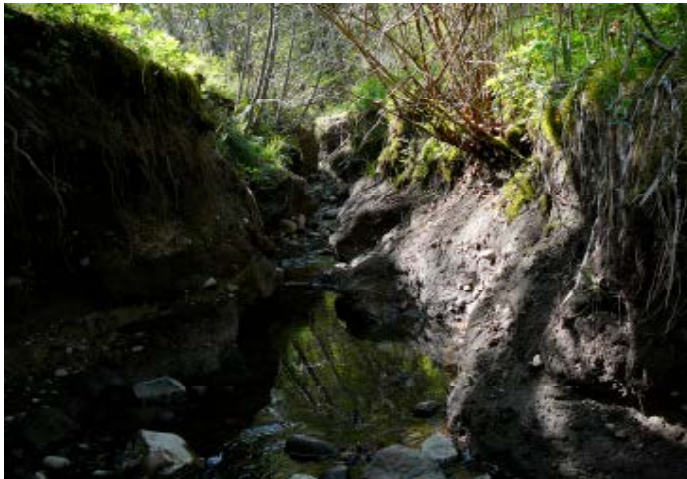
Rating: Nonfunctional

Reach 5 is approximately 170m long and extends upstream from 2190 Drennan St. to Charter's Road crossing. This reach is found within a gully and has steep slopes along both banks. This reach exhibits excessive erosion and a downcutting channel. As a result, the Rosgen channel classification is a "G4". The potential for this reach is a Rosgen "B4" and the discrepancy indicates that this reach is not in balance with the surrounding landscape characteristics.

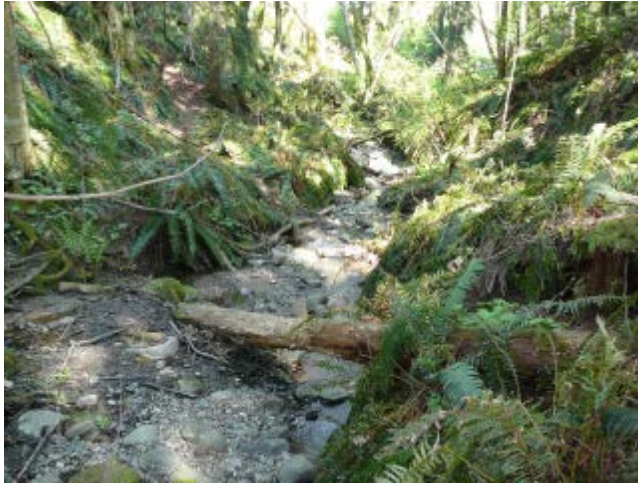
Rating: Functional-At-Risk with a downward trend

Reach 6 is approximately 300m long extending upstream from Charter's Road through residential areas and adjacent to another playing field area up to the concrete wall upstream of Brandford Road. The channel is slightly downcut, floodplain utilization is minimal, and erosion and riparian infringement are occurring. The downstream portion of the reach has steep slopes on either side and is in a gully. The upstream portion of the reach is not within a gully structure. As such, overall, the reach exhibits Rosgen "Cb4" characteristics. While the potential Rosgen morphology for this reach is also "Cb4" the reach is not at its potential as a result of the constraints.

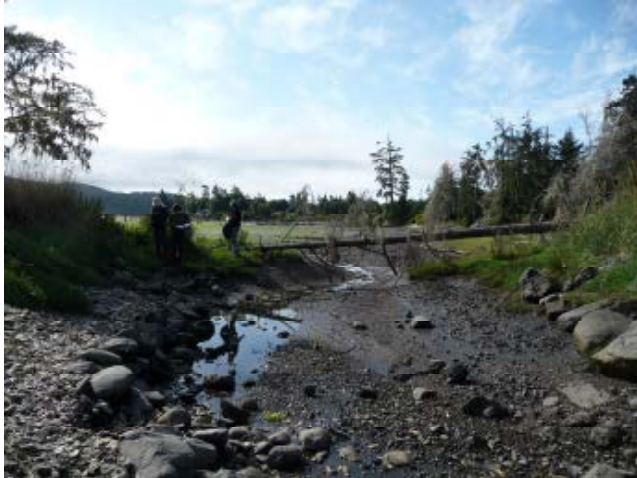
Rating: Proper Functioning Condition

Reach 1 of Wright Road Creek extends for approximately 50m from the outlet into Sooke Harbour to the upstream property boundary of 1729 Whiffin Spit Road. This reach is tidally influenced and does not have a characteristic Rosgen channel morphology. The channel has been modified and has armoured banks in the form of large rocks on both banks for the entire length of the reach. At the upstream reach break a small headcut is present that shows prevention strategies i.e. wooden boards that have been placed in front of the cut in an attempt to prevent further erosion.

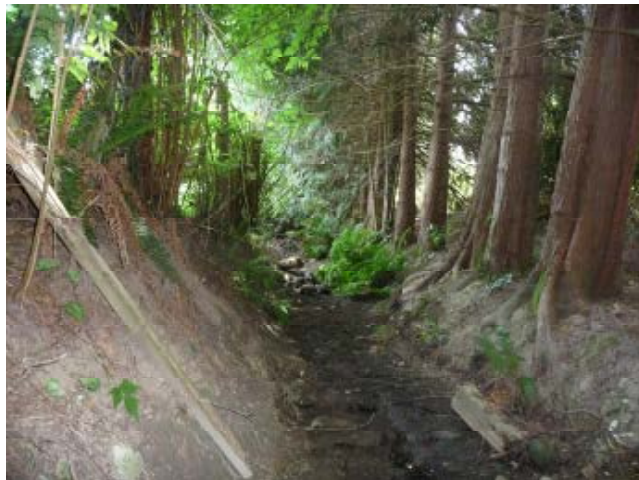
Rating: Functional-at-Risk (Downward Trend)

Reach 2 extends for about 80m from 1729 Whiffin Spit Road to the tributary confluence (where the main channel takes a sharp right turn if looking upstream). The creek is heavily constrained from activities on residential properties on both banks, as well as channelisation that has occurred. The channel is a ditch and it does not have a potential Rosgen channel classification as it is too heavily modified and constrained to classify.

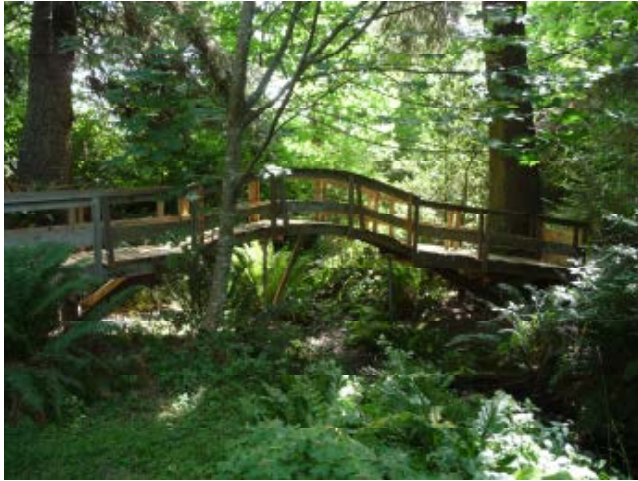
Rating: Proper Functioning Condition

Reach 3 of Wright Road Creek extends from the tributary confluence, upstream for 390m to where the channel crosses Whiffin Spit Road. The majority of the reach, except for a small section between Wright Road and Nordin Road, is heavily constrained within a narrow area between residential properties and roadways. The channel in some places is overly widened and deepened, but in other sections it has access to its floodplain and is sinuous showing Rosgen “C” channel characteristics. As a result, the channel is classified as a Rosgen “C4” channel with a small wetland area. The channel has a low gradient but still shows evidence of scour indicating it receives energetic water flows that it may be at risk in the long-term.

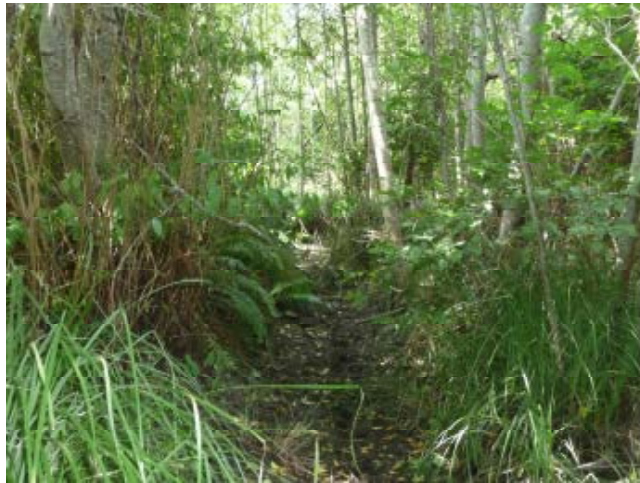
Rating: Proper Functioning Condition

Reach 4 is approximately 135m long and extends upstream from Whiffin Spit Road to the large pond at 1791 Marathon Lane. This reach is low in gradient, has a narrow obvious channel portion, and a larger floodplain accessibility area. It shows characteristics of a channelized wetland, likely as a result of the presence of residential properties on either side of this reach that have constrained a former wetland to create the existing channel.

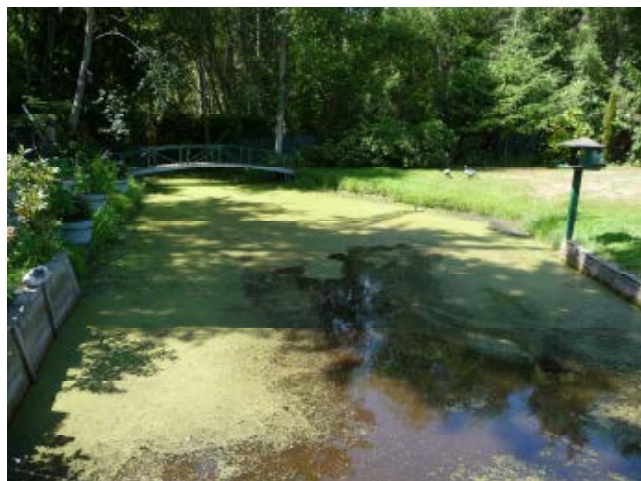
Rating: Proper Functioning Condition

Reach 5 is approximately 65m long and consists of a large pond divided by a bridged driveway. The upstream reach break is at the upstream property line of 1791 Marathon Lane where the defined pond terminates into a forested wetland area.

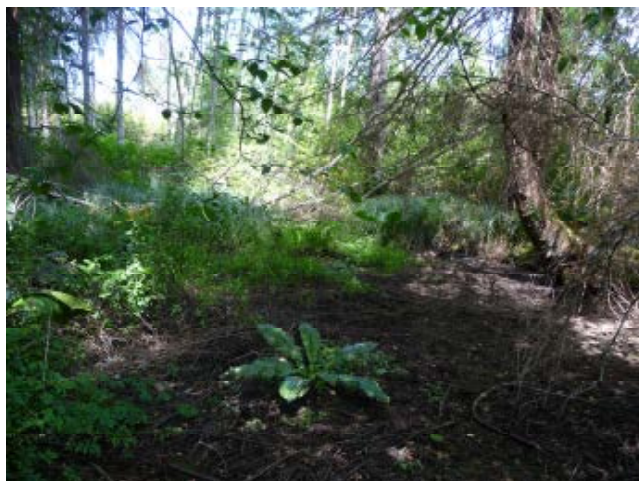
Rating: Proper Functioning Condition

Reach 6 consists of a forested wetland that extends for approximately 60m between the upstream property boundary of 1791 Marathon Lane and the upstream property boundary of 7093 West Coast Road. The wetland does extend beyond the upstream property boundary of 7093 West Coast Road but that area is within the T'Souke First Nation lands and is outside the scope of this project. However, conditions are likely similar as the tree canopy and understory vegetation are similar beyond the property boundary.

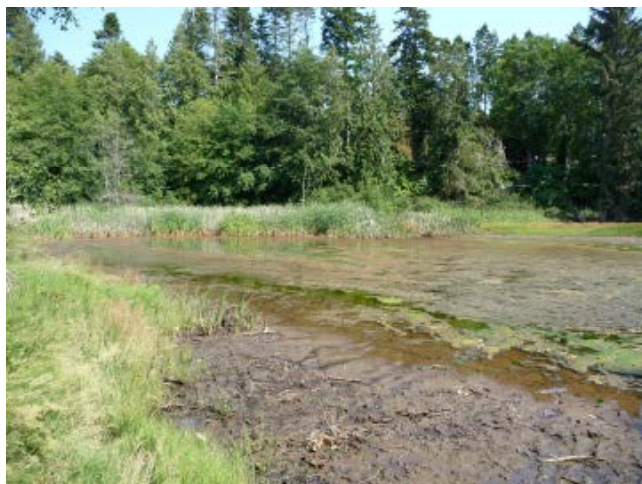
Rating: Proper Functioning Condition

Reach 1 is a large wetland located at the downstream-most portion of Ella Stream. It is approximately 60m by 45m and has an outlet channel directly into a man-made saltwater lagoon. This lagoon was excavated from an area that was historically (50+ years ago) an extension to the wetland.

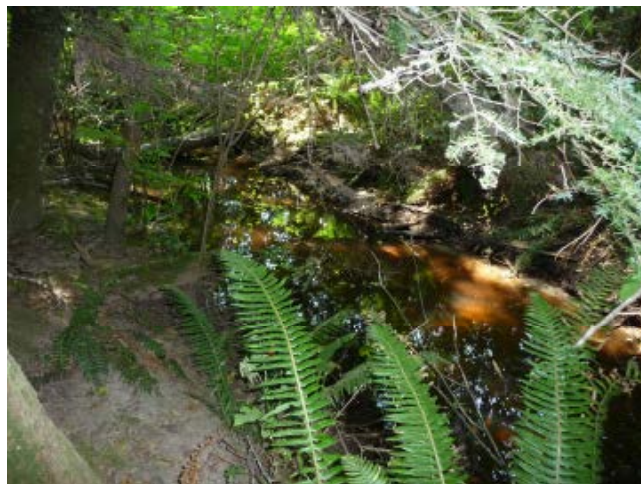
Rating: Functional-at-Risk (Downward Trend)

Reach 2 is approximately 250m long extending from the large wetland to another small section of wetland pockets. At the upstream reach break there is a large section of deposited sediment which contrasts sharply with the lack of sediment deposition in the downstream portion of the reach.

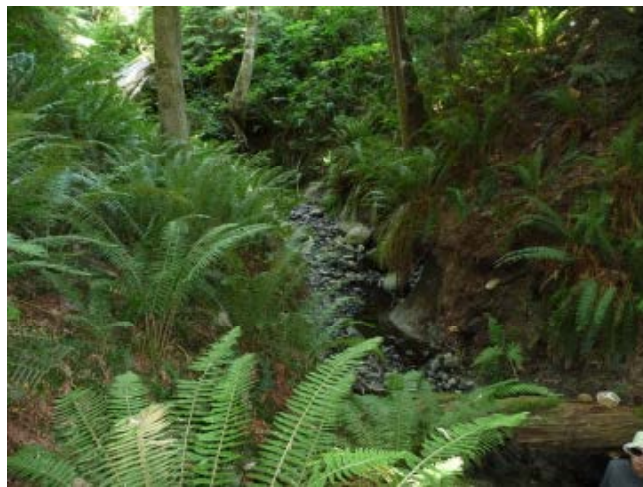
Rating: Functional-at-Risk (Downward Trend)

Reach 3 is approximately 430m long and includes the area between the deposition section at the downstream end of the reach and West Coast Road. Bounded by Ella Road to the south and West Coast Road to the north, the creek meanders in the wide riparian/forest area in between. A tributary runs along the north edge of the forested area and meets Reach 3 near its midpoint (see next summary for description of the tributary).

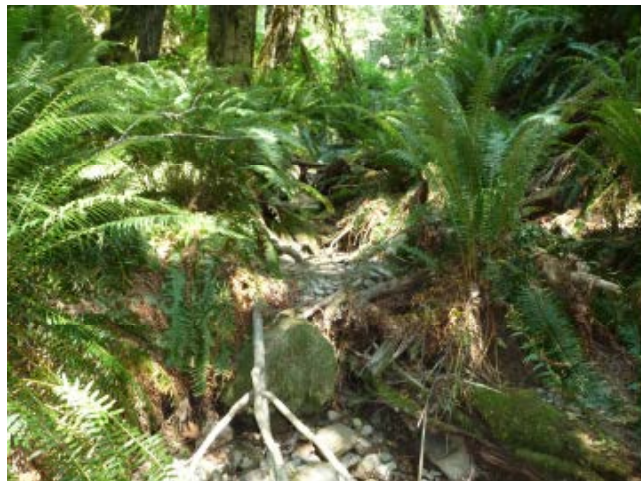
Rating: Proper Functioning Condition

This tributary runs from West Coast Road and meets the main Ella Stream Reach 3 near its mid-point. This channel is representative of a Rosgen "B3" channel, similar to the main channel (entrenched channel with cobble substrate) but with less erosion and downcutting in the channel. At the time of assessment, the channel was dry.

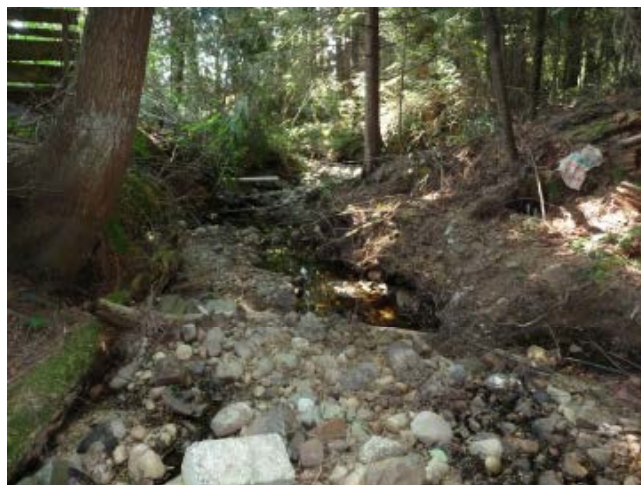
Rating: Nonfunctional

Reach 4 of Ella Stream is approximately 120m long and extends from West Coast Road upstream to the culverts under Cedar Brook Place. The reach flows between residential properties and is, constrained (no floodplain access) along both banks. The Rosgen channel classification for this reach is a "B3/4" channel with more cobble than gravel and evidence of pool sections.

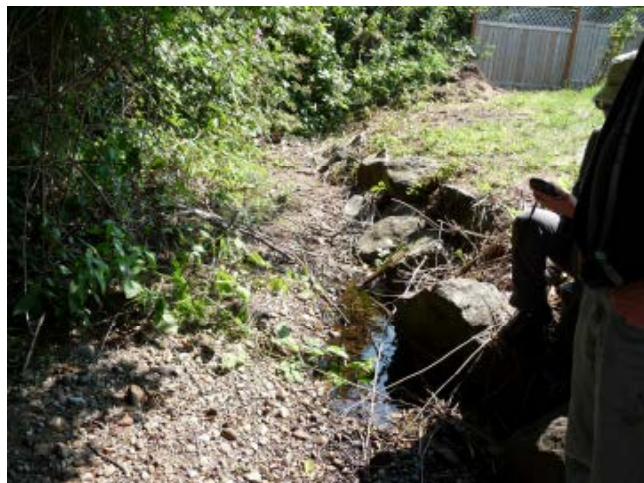
Rating: Nonfunctional

Reach 5 of Ella Stream is located between Cedar Brook Place and Henlyn Road and is approximately 72m long. At the downstream end of the reach, the right bank is adjacent to Cedar Brook Park while the left bank borders a residential property. At the upstream end, the creek runs alongside residential properties on both banks.

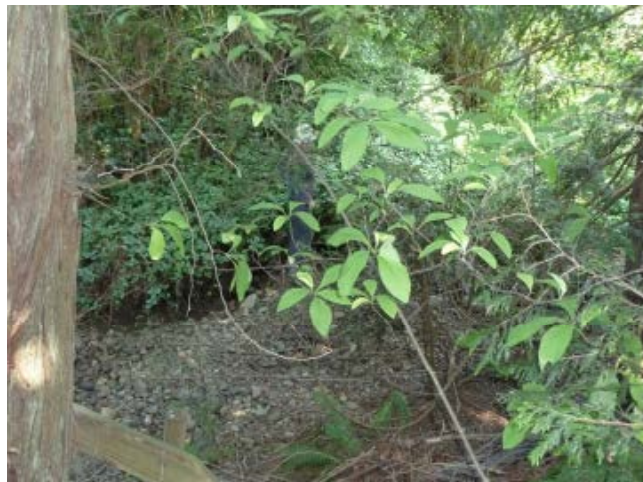
Rating: Functional-at-Risk (Downward Trend)

Reach 6 of Ella Stream extends for approximately 85m from Henlyn Road to 7142 Grant Road. The Rosgen channel character is a "B3" due to the gradient and presence of pools with a cobble channel bottom.

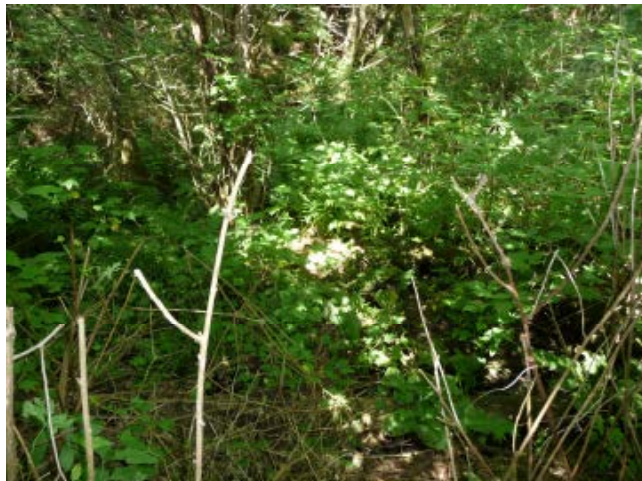
Rating: Proper Functioning Condition

Reach 7 extends from 7142 Grant Road upstream for 425m to the property boundary of 2233 Firwood Place. The reach is located in a large forested area between the Grant Road Rustic Cooperative and Firwood Place; a section of this is within the boundaries of Firwood Park.

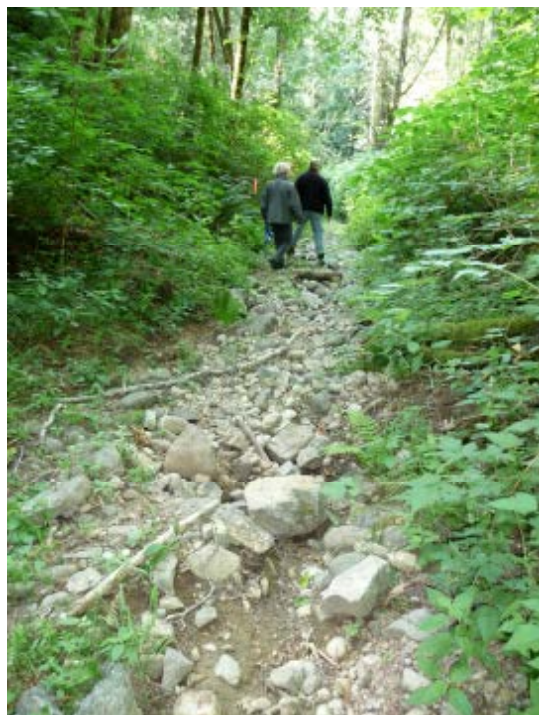
Rating: Nonfunctional

Reach 8 of Ella Stream starts at the upstream property boundary of 2233 Firwood Place and continues upstream along an old skid road for approximately 50m before another forested wet area opens up. The channel is a Rosgen "B3/4", which is the same character as its potential; however, its condition is not at potential.

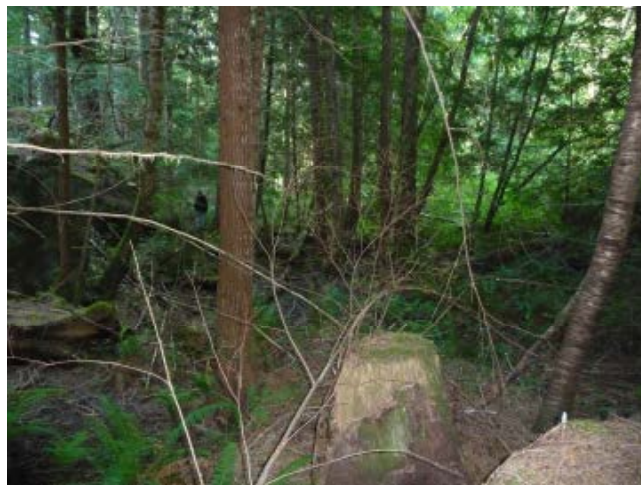
Rating: Proper Functioning Condition

Reach 9 is the top of the Ella Stream Watershed and extends for approximately 295m from the end of the single defined channel to the bedrock outcrops. As with Reach 7, Reach 9 cannot be defined using Rosgen terminology as it is composed of multiple channels and intermittent moist, ponding areas. At the time of assessment, no flows were observed but the soils were moist.
