REQUEST FOR PROPOSALS
FOR
DEMOLITION, REMOVAL, AND SITE GRADING
OF 2076 OTTER POINT ROAD
FOR THE DISTRICT OF SOOKE, BC

Warehouse Located at 2076 Otter Point Road, Sooke BC

Hazardous Materials Survey of 2076 Otter Point Road, Sooke BC

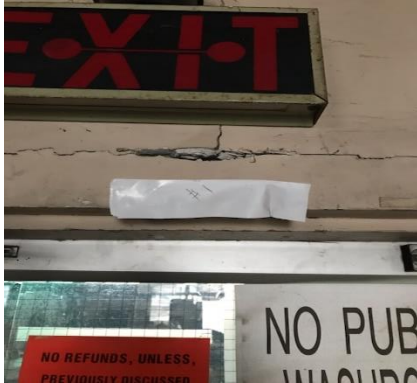
Photo 1: Drywall Joint Compound
Store Front W. Wall – (ND)

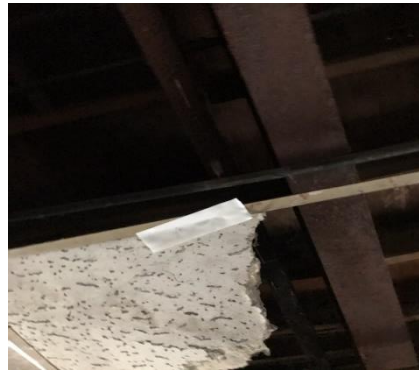
Photo 2: Acoustic Tile Large Fissure
Store Front N. Ceiling - (ND)

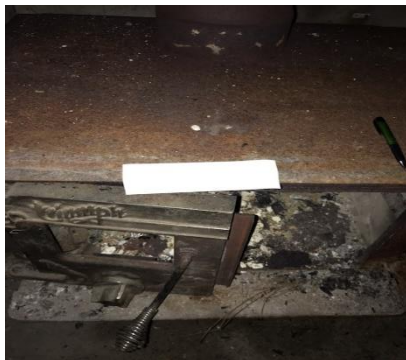
Photo 3: Firebox Brick -
Store Front Fireplace – (ND)

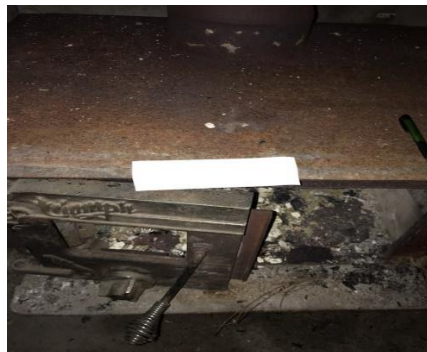
Photo 4: Firebox Rope Gasket
Store Front Fireplace – (ND)

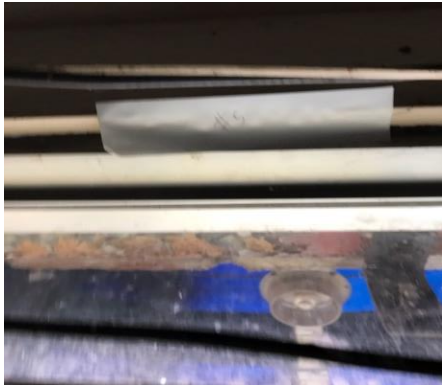
Photo 5: Drywall Joint Compound– Store Front E. Wall (ND)

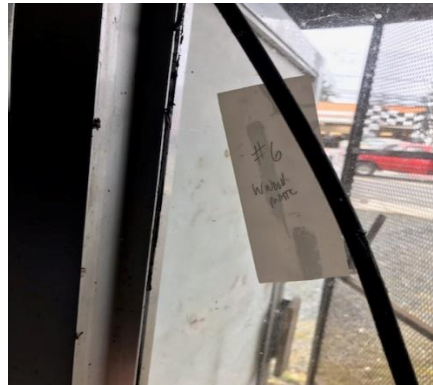
Photo 6: Mastic
Store Front E. Window – (ND)

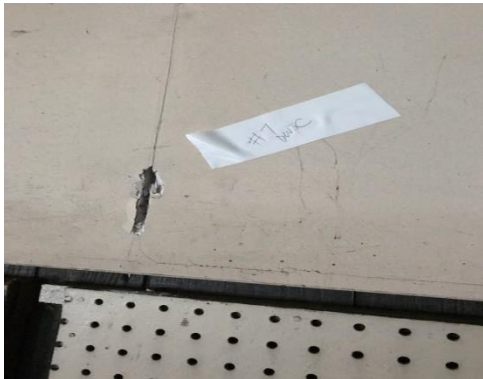
Photo 7: Drywall Joint Compound – Store Front S. Wall - (ND)

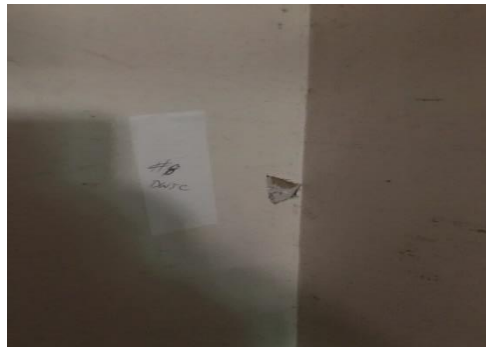
Photo 8: Drywall Joint Compound
Office S. Wall – (ND)

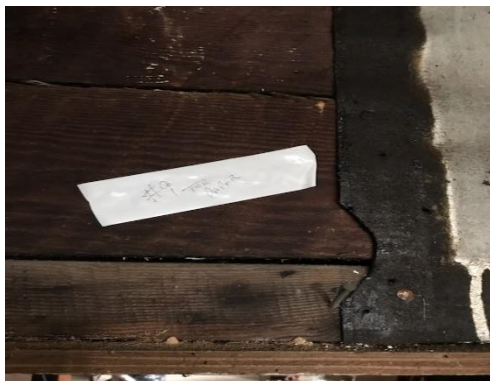
Photo 9: Tar Paper – Outside Office
N Wall – (ND)

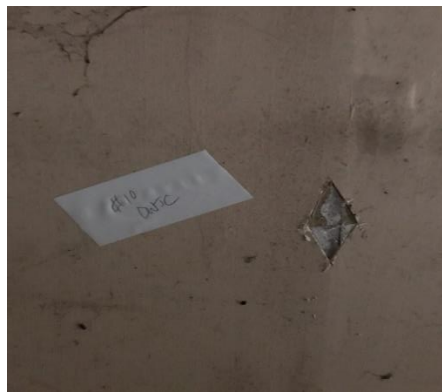
Photo 10: Drywall Joint Compound
Loading Zone SE. Wall – (ND)

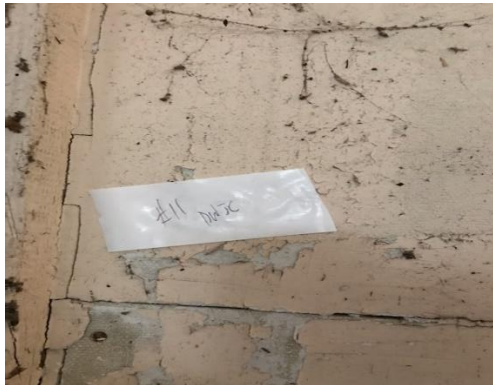
Photo 11: Drywall Joint Compound–
Loading Zone S. Wall - (ND)

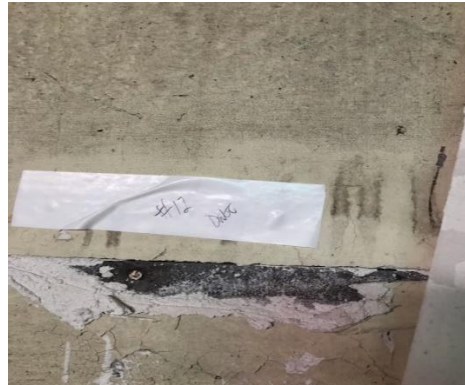
Photo 12: Drywall Joint Compound
Warehouse E. Wall – (ND)

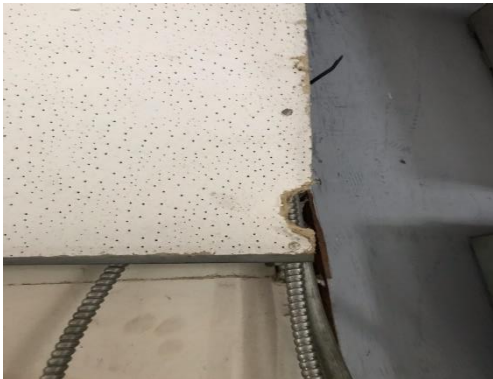
Photo 13: Acoustic Tile – Upstairs Room
N. Ceiling - (ND)

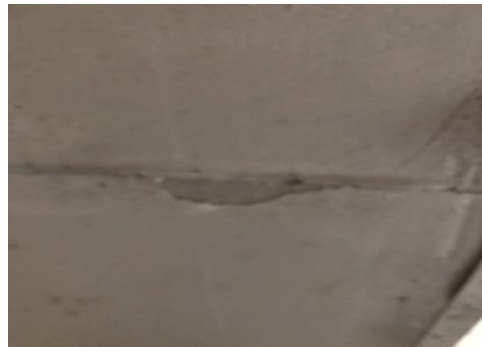
Photo 14: Drywall Joint Compound –
Upstairs Room N Ceiling – (ND)

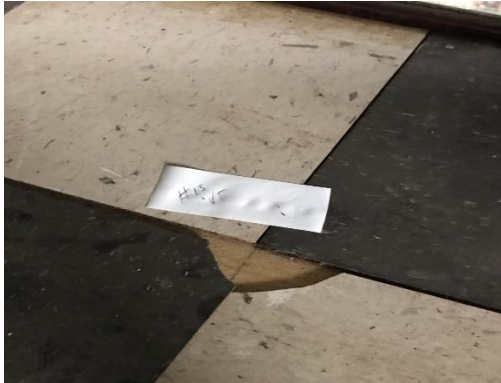
Photo 17a&b: Vinyl Floor Tile (White and Black) Store Front Glass Cabinet - (ND)

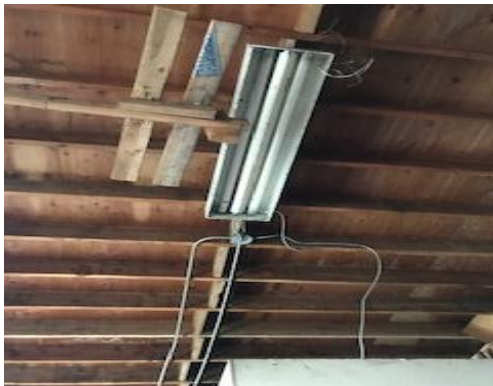
Fluorescent light ballasts were observed. These fixtures may contain PCB ballasts. There are several methods that can be used to determine if ballasts contain PCBs:

Unfortunately, after many years of exposure to heat, dust and other elements, the labels on old ballasts become illegible or are missing altogether. If PCBs cannot be ruled out based on the age of the building or lighting system as a whole, the prudent response would be to treat suspect ballasts as if they did contain PCBs. This is especially true if PCB ballasts have already been found in the facility.

Photo 19 - Ballasts

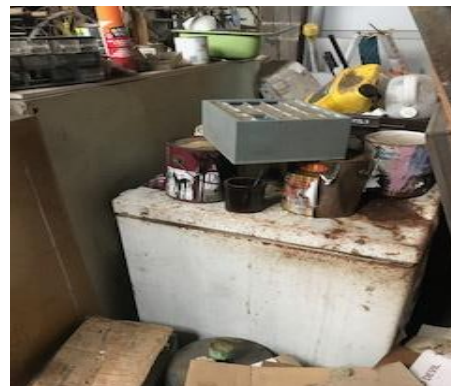
A freezer was observed but due to the number of items in the warehouse as cleanup is performed additional Fridge or Freezer may be uncovered– refrigerators made before 2005 may contain ODSs. ODSs such as chlorinated fluorocarbons (CFCs) were used in chemical fire suppression systems and refrigeration and air conditioning units. In the case of demolition, these ODSs will require proper recovery and disposal by a licensed contractor, in accordance with the BC Ozone-Depleting Substances Regulation.

Photo 20 - Freezer

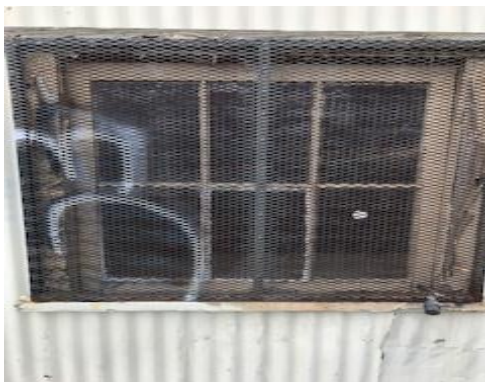
These are over the WorkSafeBC limit of 0.5% and must be safely removed before renovation, demolition, or any other type of disturbance that could release fibers into the air.

2 Front store windows were inaccessible during time of inspection due to metal grating. This mastic is presumed to contain and would require further testing to confirm ACM.

Photo 21 - Mastic ACM

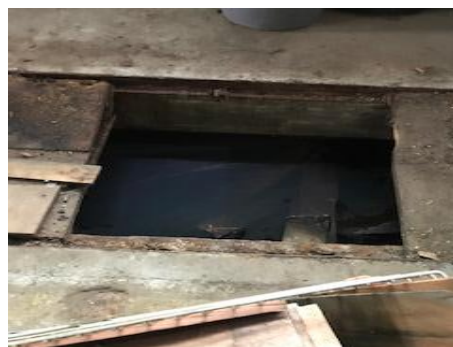
Photo 22 - Pit full of Water

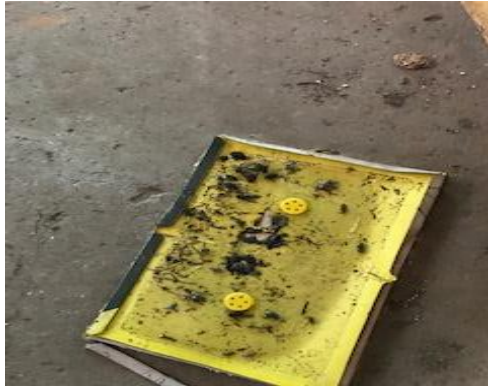
In Canada, the hantavirus is found only in wild mice, specifically the deer mouse (*Peromyscus maniculatus*). The mice shed the virus in their urine, droppings and saliva. The virus is mainly transmitted to people when they breathe in air contaminated with the virus. Rodent feces were observed see attached photo.

Photo 24 – Rodent Feces

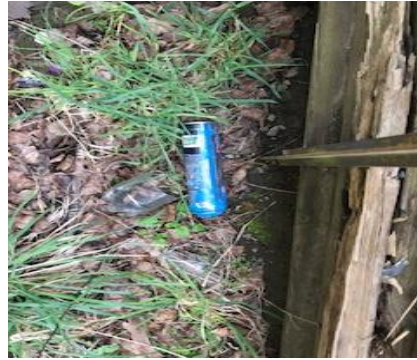
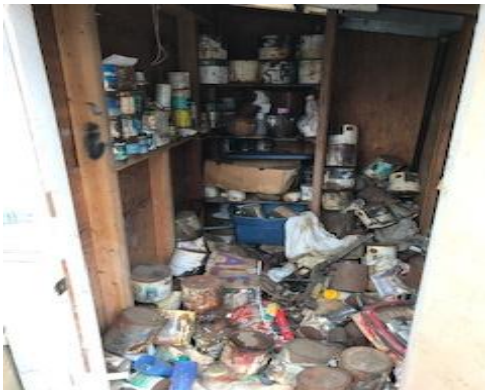
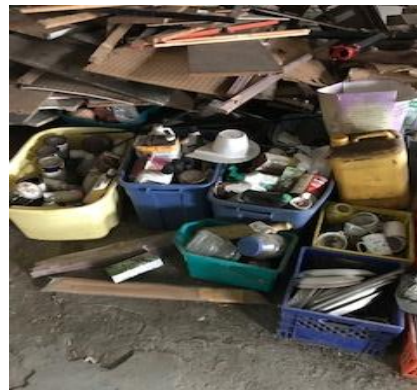
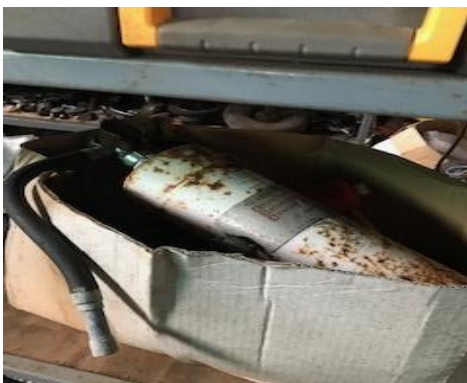
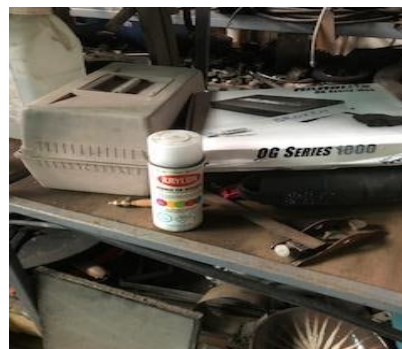
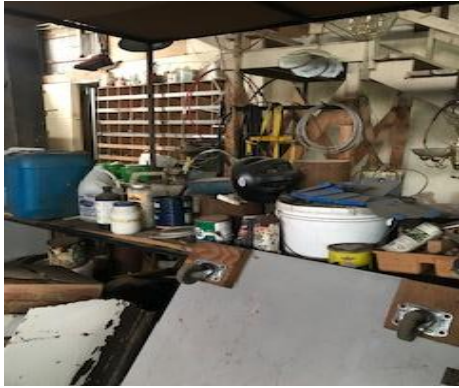
Photo - Chemicals

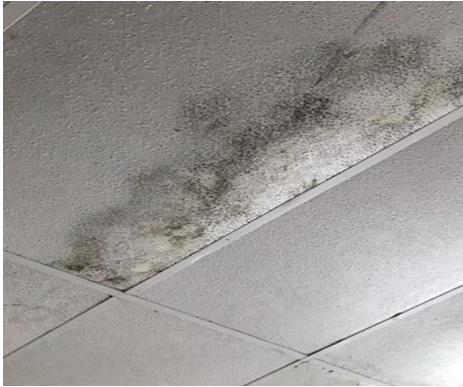
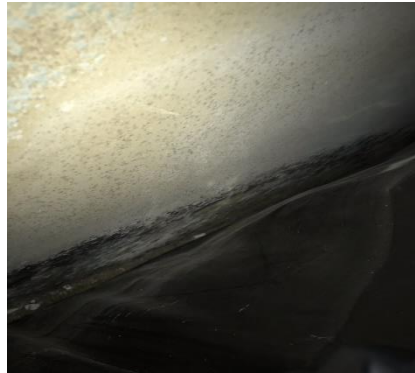
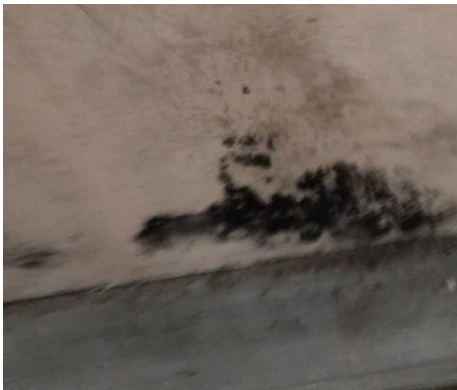
Black mould was observed throughout building and will require appropriate abatement prior to demolition. See photo's.

Photo – Mould 1
