FINAL
Baseline Property Condition
Assessment with Specialist Reviews
of the Mechanical, Electrical, Fire and
Life Safety Systems

2205 Otter Point Road
Sooke, British Columbia

March 2, 2020

Pinchin File: 249997.000

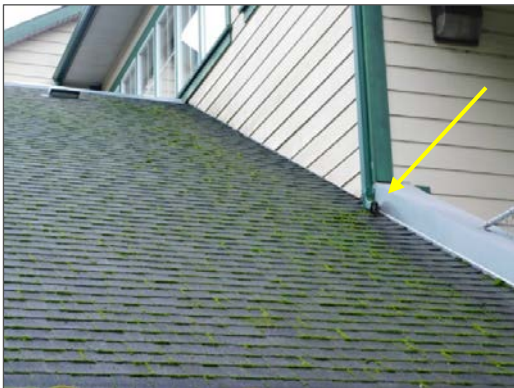
Organic growth and the improper termination of downspouts were noted on the asphalt-shingled roof system atop Site Building A.

<ul style="list-style-type: none"> Organic growth and the improper termination of downspouts were noted on the asphalt-shingled roof system atop Site Building A. 	<ul style="list-style-type: none"> Remove organic growth. Consideration should be given to extend the downspout into the lower eavestroughs to prevent accelerated deterioration of asphalt shingles at localized areas.
<ul style="list-style-type: none"> Detached downspout section was noted at the southwest corner of Site Building A. 	<ul style="list-style-type: none"> Re-secure downspout sections.
<ul style="list-style-type: none"> Eavestrough surrounding the asphalt-shingled roof system atop Site Building A were noted to be clogged with leaves and debris. 	<ul style="list-style-type: none"> Remove leaves and debris from eavestroughs.
<ul style="list-style-type: none"> Trees were noted to be encroaching onto the asphalt-shingled roof surfaces of Site Building A. 	<ul style="list-style-type: none"> Trees should be pruned to minimize the accumulation of leaves and organic debris build-up.

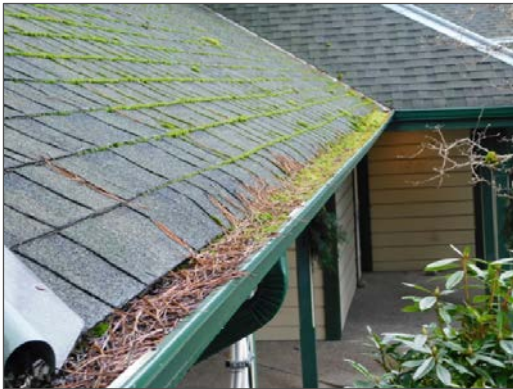
Eavestrough surrounding the asphalt-shingled roof system atop Site Building A were noted to be clogged with leaves and debris.

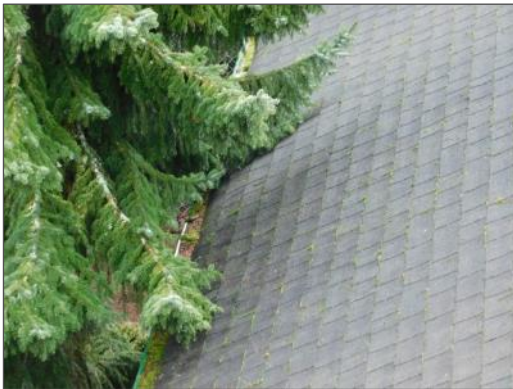
Trees were noted to be encroaching onto the asphalt-shingled roof surfaces of Site Building A.

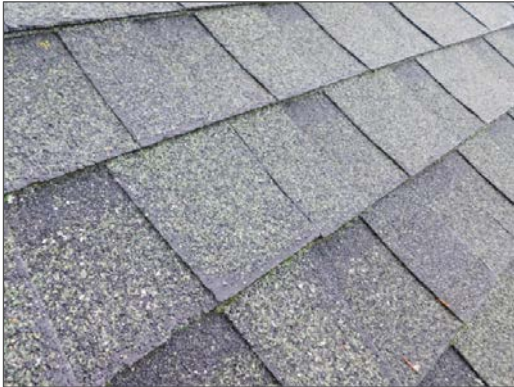
Granule loss was noted at various location of the asphalt-shingled roof system atop Site Building A.

<ul style="list-style-type: none"> Granule loss was noted at various location of the asphalt-shingled roof system atop Site Building A. 	<ul style="list-style-type: none"> Undertake localized repairs until the recommended roof replacement.
<ul style="list-style-type: none"> Signs of corrosion were noted on the metal flashings atop Site Building A. 	<ul style="list-style-type: none"> Undertake localized repairs until the recommended roof replacement.
<ul style="list-style-type: none"> Signs of ponding, organic growth, debris, and loose wiring were noted on the BUR atop Site Building A. 	<ul style="list-style-type: none"> Remove organic growth and debris as part of routine maintenance. Consideration should be given to reviewing the slope or additional drains during the next recommended roof replacement.
<ul style="list-style-type: none"> Failed sealants were noted around HVAC service penetrations atop Site Building A. 	<ul style="list-style-type: none"> Replace sealants.

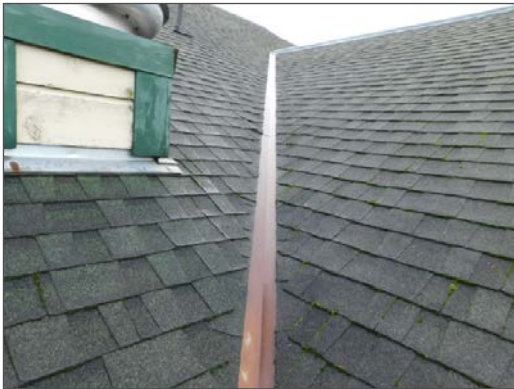
Signs of corrosion were noted on the metal flashings atop Site Building A.

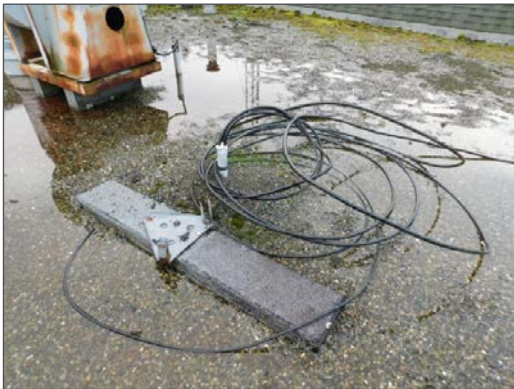
Signs of ponding, moss growth, debris, and loose wiring were noted on the BUR atop Site Building A.

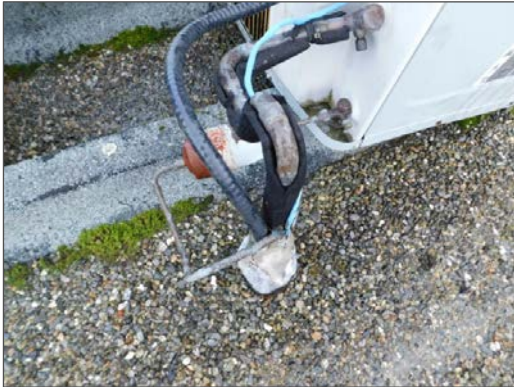
Failed sealants were noted around HVAC service penetrations atop Site Building A.

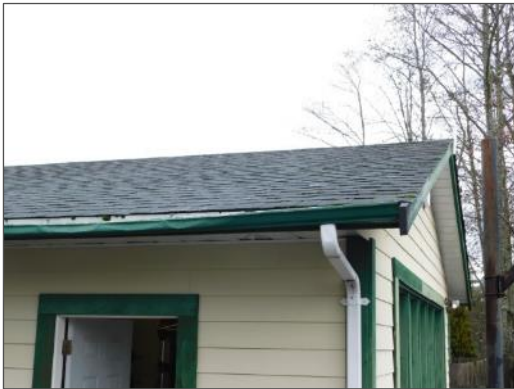
Warped gutter sections were noted atop Site Building B.

<ul style="list-style-type: none"> Warped gutter sections were noted atop Site Building B. 	<ul style="list-style-type: none"> Replace warped gutter sections.

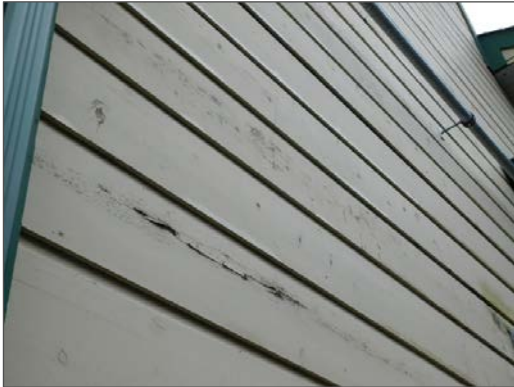
Peeling paint and localized damages were noted on the wood siding of Site Building A.

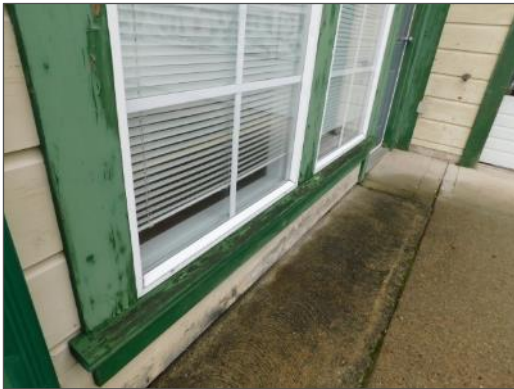
Peeling paint and localized damages were noted on the localized wooden trim boards of Site Building A.

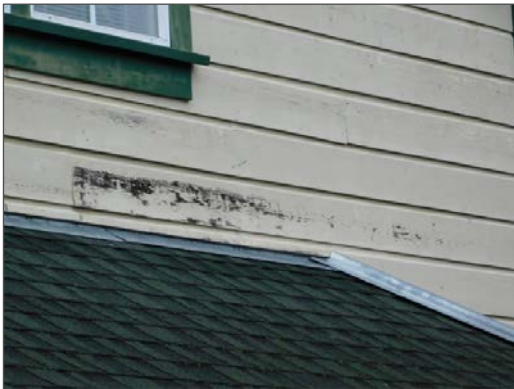
Organic stains were noted at localized wall sections of Site Building A.

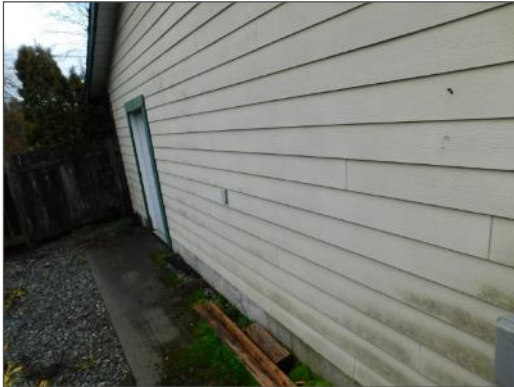
Organic stains were noted at localized wall sections of Site Building B.

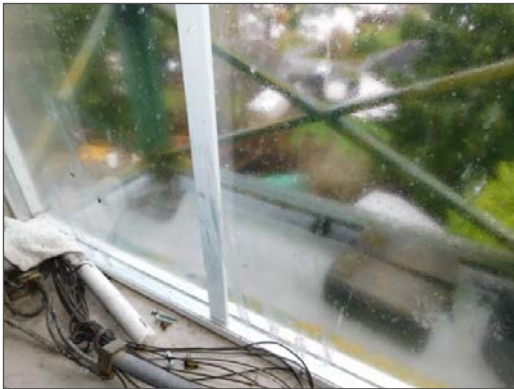
A failed IG unit was noted on a window on the north elevation of Site Building A.

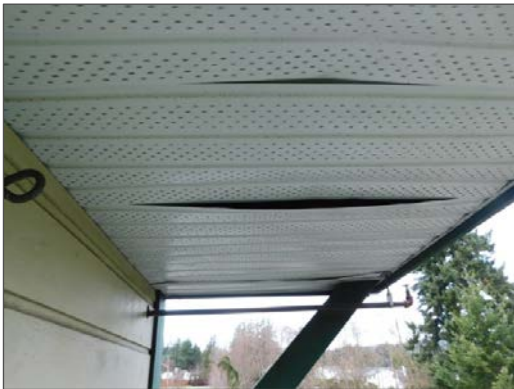
Loose and detached metal soffit sections were noted at localized areas of Site Building A.

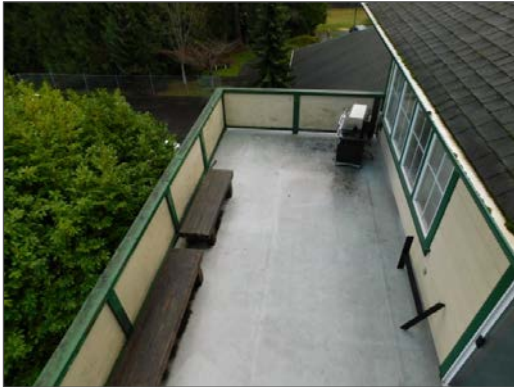
Note: Localized ponding and stains.

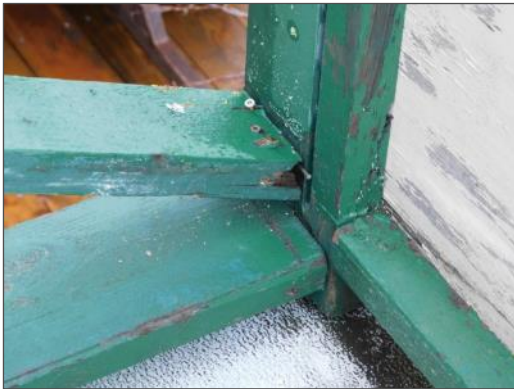
Localized damage and deterioration were noted on the wood guards serving the balcony systems.

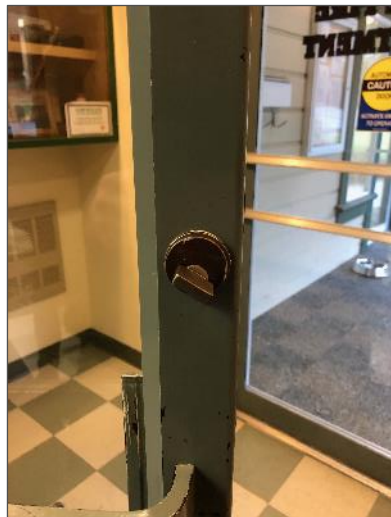
Various door handles were noted to be of residential grade and were of unsatisfactory condition.

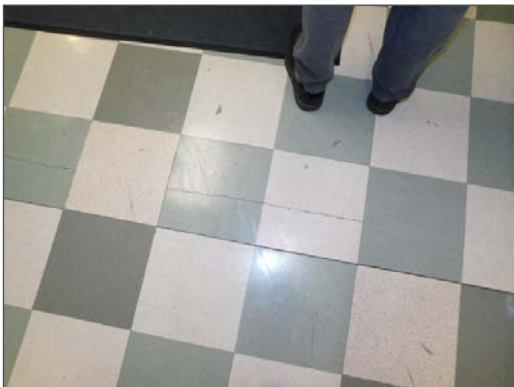
Localized cracks were noted on the flooring within Site Building A.

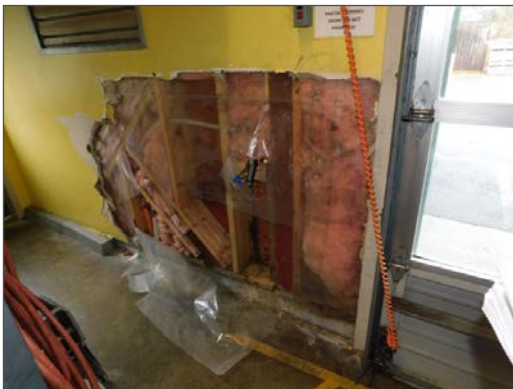
Incomplete finishing was noted within Site Building A due to reported repairs/inspection.

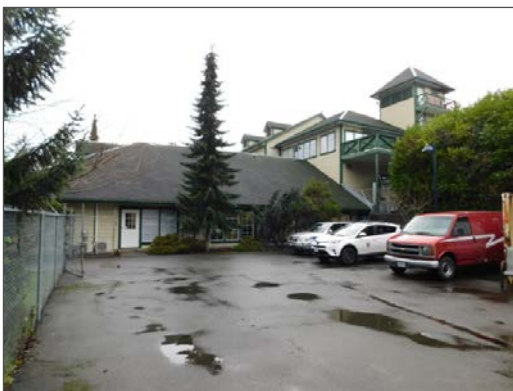
Note: Localized ponding.

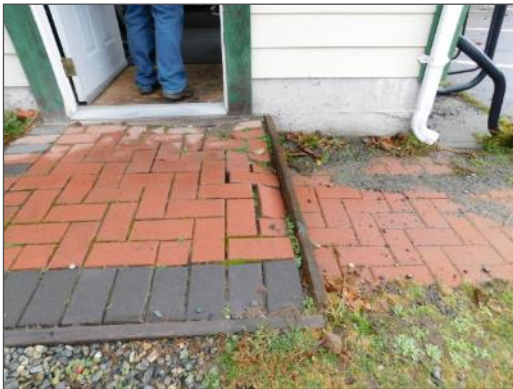
Areas of settled paver stones were noted at the entrance to Site Building B.

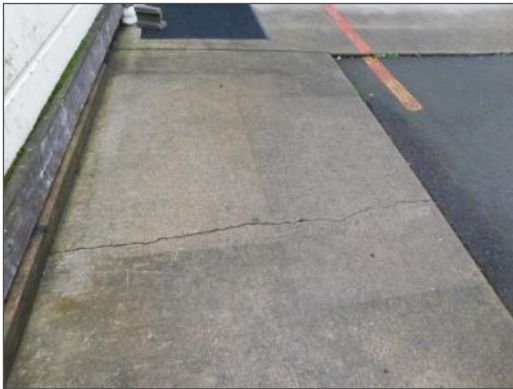
Localized cracks were noted on the concrete walkways.

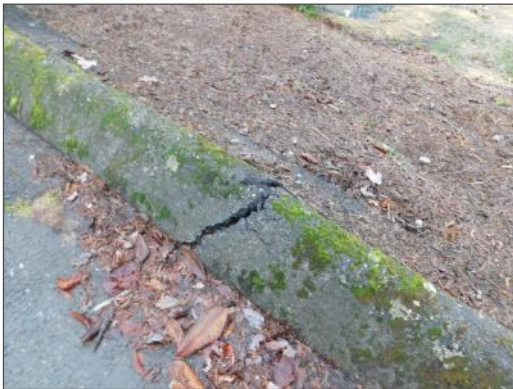
Localized cracks were noted on the concrete curbs.

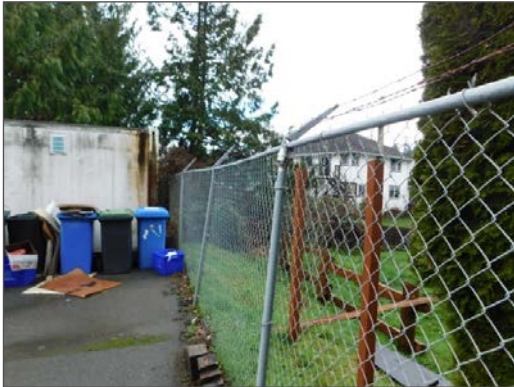
<ul style="list-style-type: none"> • Signs of leaning were noted at localized sections of the chain-link fencing. 	<ul style="list-style-type: none"> • Undertake localized repairs of the chain-link fencing as needed.

Signs of leaning were noted at localized sections of the chain-link fencing.

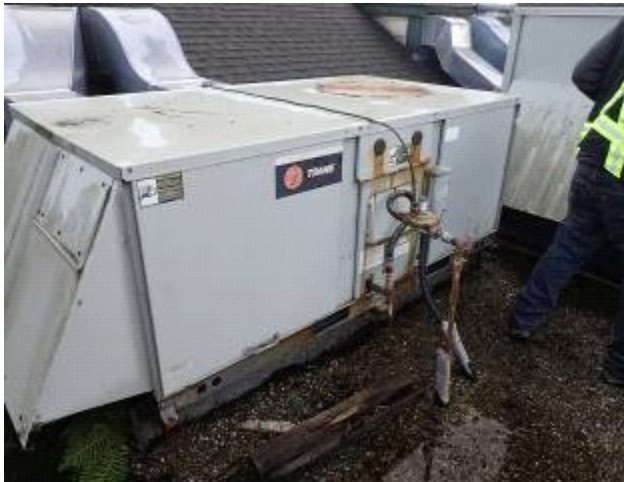
Figure 2: Packaged air-conditioner serving Fire Hall Lounge.

Fire Hall Rooftop Air-Conditioning Units	
Age of System/Equipment	25 years
Typical Service Life	15-20 years
Remaining Service Life	0 years
Replacement Cost	\$30,000
Recommended Replacement Timeframe	1-5 years
Recommended Upgrades/Repairs?	No.
Cost for Upgrades/Repairs	\$0
Recommended Upgrade Timeframe	N/A
Consequences of not performing upgrade	Possible loss of heating if unit(s) fail.

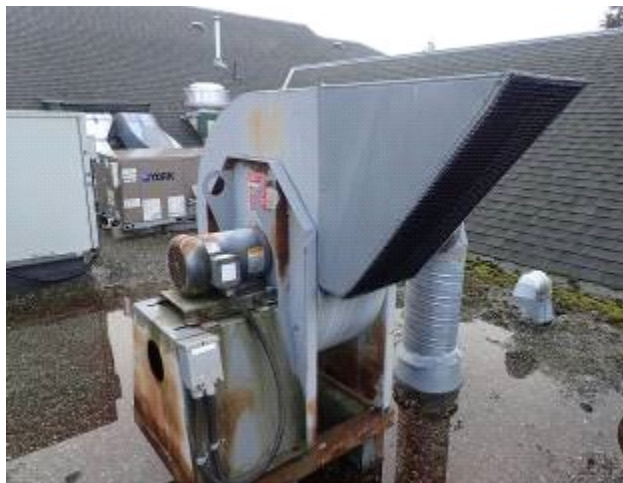
Figure 8: Fire Hall apparatus floor - exhaust fan.

Fire Hall, Apparatus Floor Exhaust Fan	
Age of System/Equipment	25 years
Typical Service Life	20-25 years
Remaining Service Life	0 years
Replacement Cost	\$4,000
Recommended Replacement Timeframe	1-5 years
Recommended Upgrades/Repairs?	Yes - Detailed inspection and testing may allow life extension.
Cost for Upgrades/Repairs	\$1,000
Recommended Upgrade Timeframe	1-5 years
Consequences of not performing upgrade	Increased risk of fan failure.

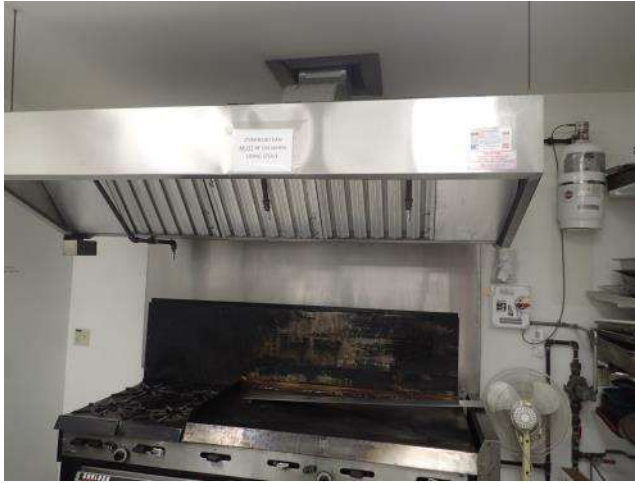
Figure 12: Fire Hall - Lounge kitchen exhaust hood.

Fire Hall, Kitchen Ventilation System	
Age of System/Equipment	25 years
Typical Service Life	20-25 years
Remaining Service Life	0 years
Replacement Cost	\$4,000
Recommended Replacement Timeframe	1-5 years
Recommended Upgrades/Repairs?	Yes - Detailed inspection and testing may allow life extension for fan.
Cost for Upgrades/Repairs	\$1,000
Recommended Upgrade Timeframe	1- 5 years.
Consequences of not performing upgrade	Increased risk of fan failure.
Additional Recommended Repairs	Yes - identify source of gas leak. Replace kitchen stove and piping if leak cannot be repaired.
Cost for Additional Repair	\$1,000
Consequences of not performing additional repair	Ongoing gas leak. Safety concern and excess energy consumption.

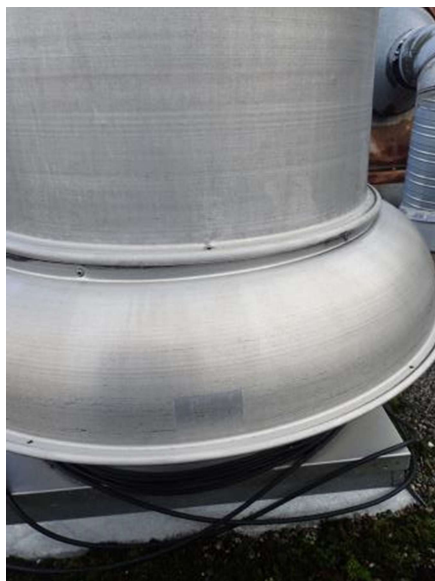
Figure 14: Fire Hall - Washroom exhaust fan.

Fire Hall, Washroom Exhaust System	
Age of System/Equipment	25 years
Typical Service Life	20-25 years
Remaining Service Life	0 years
Replacement Cost	\$15,000
Recommended Replacement Timeframe	1-5 years
Recommended Upgrades/Repairs?	No.
Cost for Upgrades/Repairs	\$0
Recommended Upgrade Timeframe	N/A
Consequences of not performing upgrade	N/A

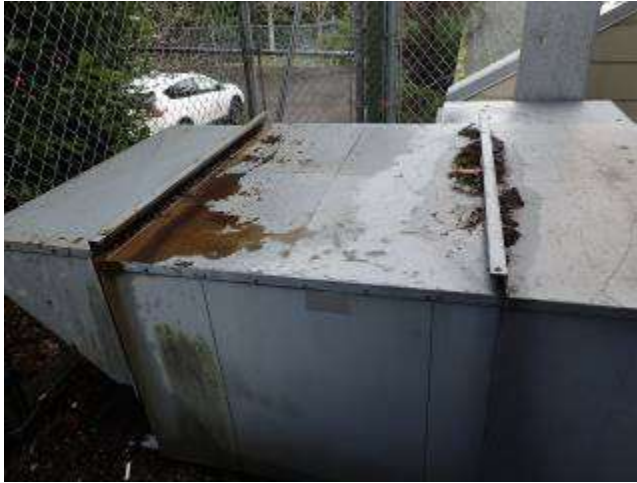
Municipal Offices, Makeup Air Unit, Outdoor Ducting and Exhaust Air Heat Recovery	
Age of System/Equipment	25 years
Typical Service Life	15-20 years
Remaining Service Life	0 years
Replacement Cost	\$30,000 (including engineering, ductwork and heat recovery system).
Recommended Replacement Timeframe	Immediately
Recommended Upgrades/Repairs?	No.
Cost for Upgrades/Repairs	\$0
Recommended Upgrade Timeframe	N/A
Consequences of not performing replacement	System does not meet code requirements for fresh air supply to the building.

Figure 15: Municipal Hall – Abandoned makeup air unit.

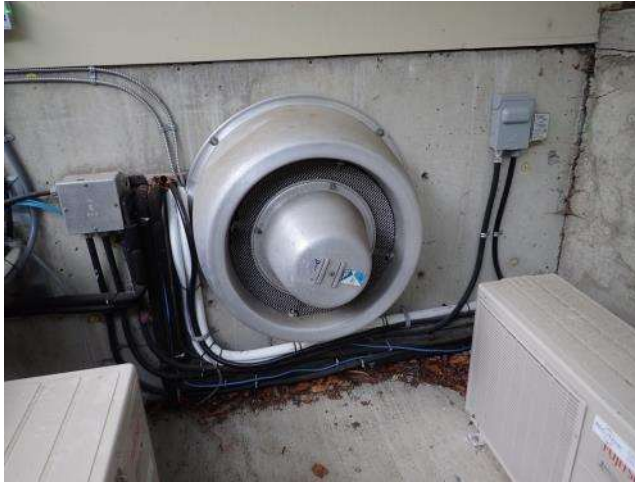
Figure 19: Municipal Hall – Washroom exhaust fan.

The washroom exhaust fan is a horizontally discharged centrifugal unit original to the building. No operational concerns were reported or observed. However, the fan is now beyond its median anticipated service life of 20-25 years. While it is possible that some extension of the life of this piece of equipment may be possible, replacement would allow installation of a heat-recovery ventilation system (please refer to Section 0 above for details).

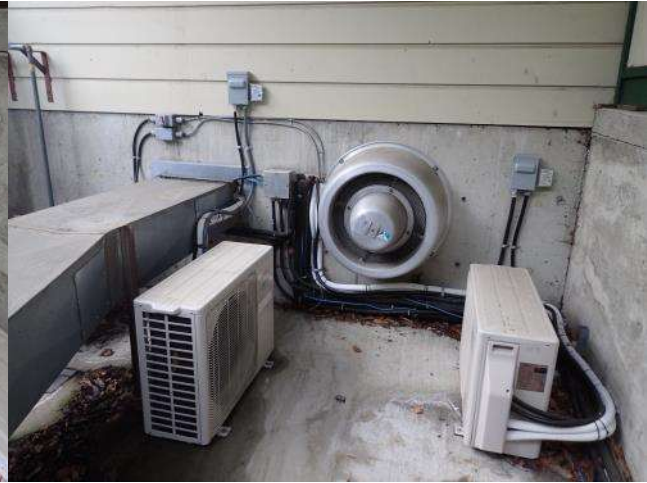
Figure 20: Municipal Hall – Washroom exhaust fan, adjacent to makeup air duct. Possibly suitable to replace both with a heat recovery ventilator.

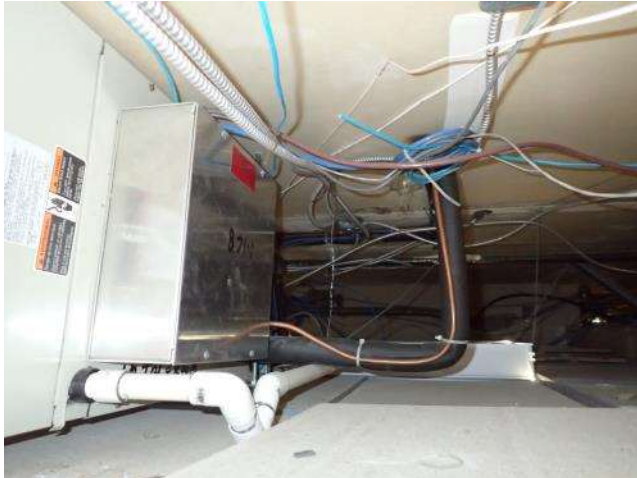
Figure 21: Municipal Hall - Typical ceiling-mounted split system ducted indoor unit (old).

In-Ceiling Ducted Split Systems	
Age of System/Equipment	25 years
Typical Service Life	15 years
Remaining Service Life	0 years
Replacement Cost	\$65,000
Recommended Replacement Timeframe	1-5 years
Recommended Upgrades/Repairs?	No.
Cost for Upgrades/Repairs	\$0
Recommended Upgrade Timeframe	N/A
Consequences of not performing upgrade	N/A

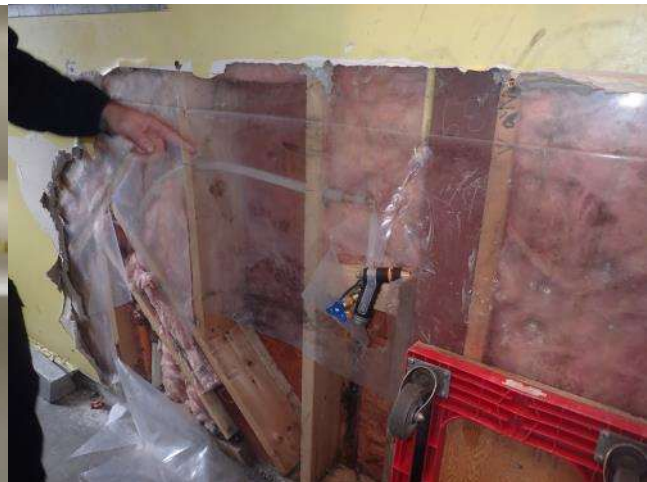
Domestic Water Piping Systems	
Age of System/Equipment	25 years
Typical Service Life	Variable for cPVC
Remaining Service Life	0 years
Replacement Cost	\$100,000
Recommended Replacement Timeframe	Immediately
Recommended Upgrades/Repairs?	Yes – Detailed inspection and testing may allow life extension.
Cost for Upgrades/Repairs	\$0
Recommended Upgrade Timeframe	N/A
Consequences of not performing replacement	Costly water damage due to failed pipes.

Figure 30: Fire Hall - Hose bib piping replacement due to failed cPVC domestic cold water piping.

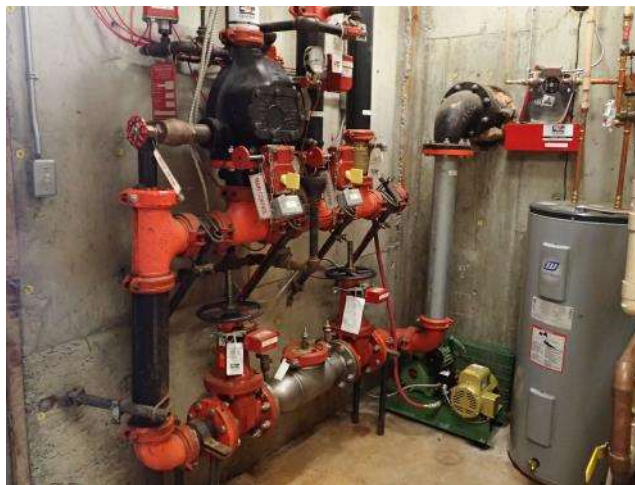
Figure 31: Sprinkler system (left), including galvanized inlet pipe and lack of fire-stopping at wall.

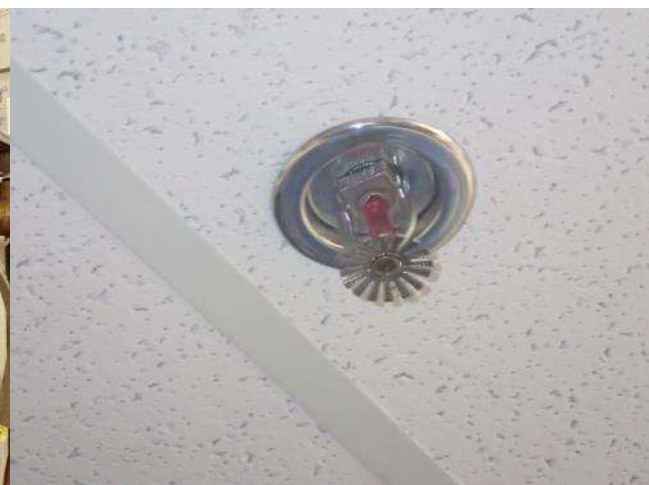
Figure 34: Typical sprinkler head in office space. Coverage not compliant with code in some areas.
