5-Year Road Improvement Program

2017 Pavement Condition Assessment

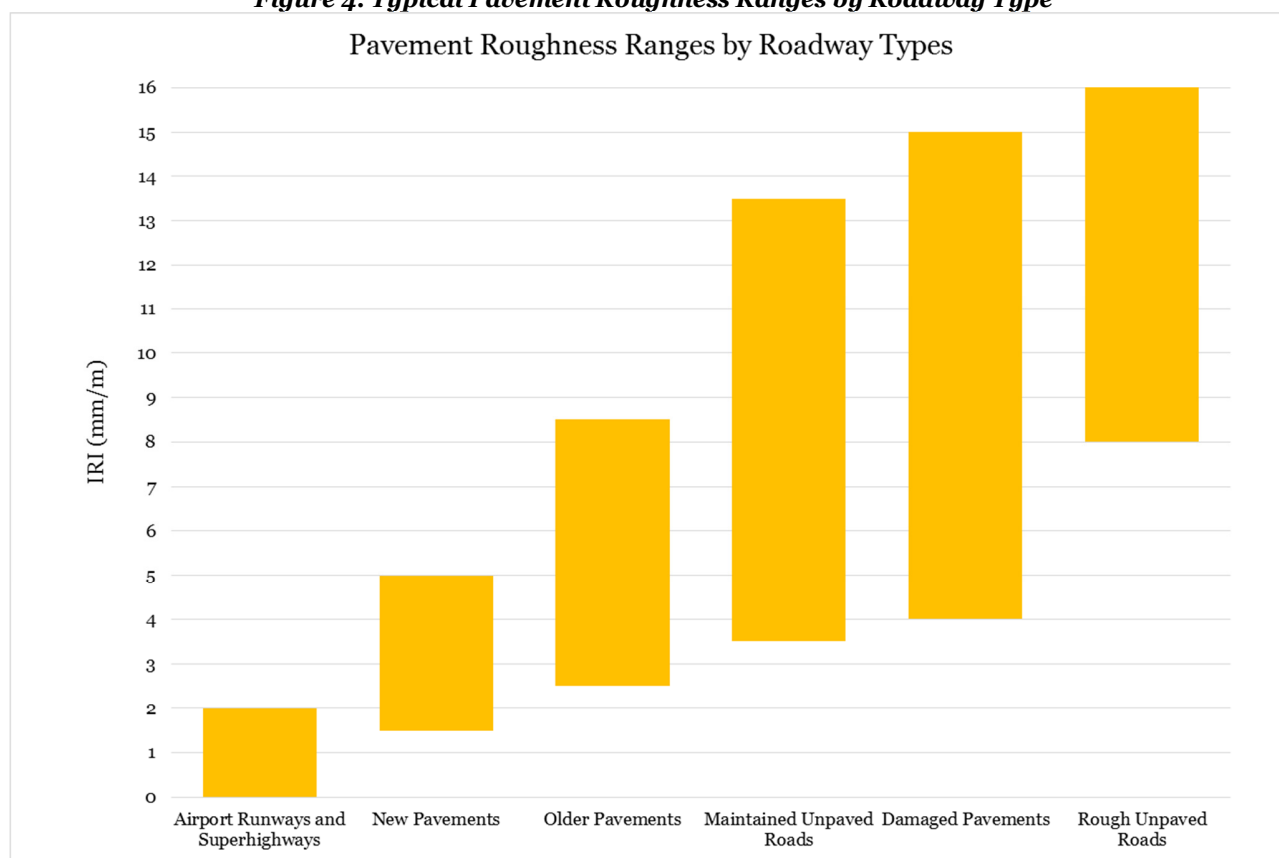
Figure 4: Typical Pavement Roughness Ranges by Roadway Type

Typical values in paved municipal environments would be between 1.5 for newly paved construction through 5-6 for deteriorated pavements. Values greater than 5-6 are often due to surface obstructions such as utility trenches or surface hardware (i.e. manhole covers, catch basins, etc.) located in the driving lanes. For clarification, the chart in Figure 4 shows the ranges that should be expected by roadway type.

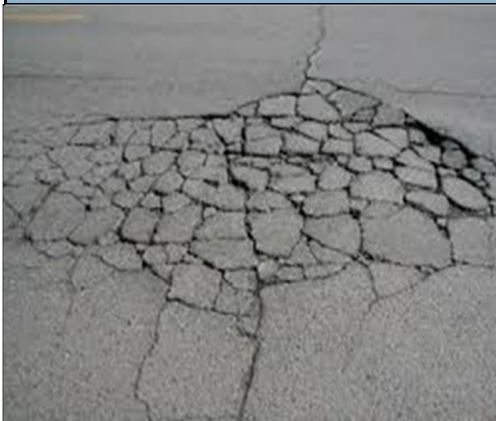
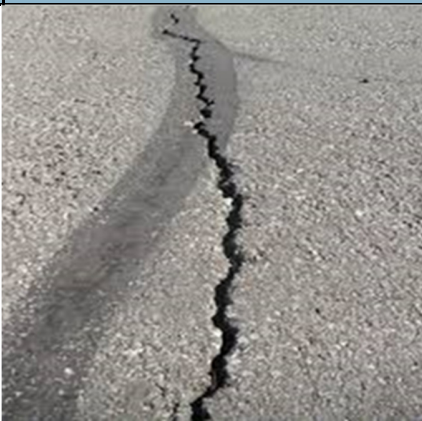
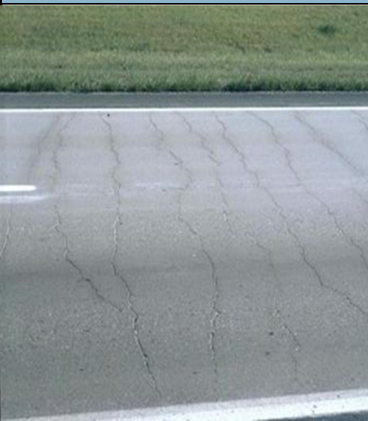
Table 3: Cracking Defect Types

Alligator Cracking	Longitudinal Cracking	Transverse Cracking

The crack index can range from 0 to 100, with 0 being no cracks and 100 being cracked throughout. It is derived by combining the severity and density ratios of each crack defect, then applying a weighting factor to each cracking type. The weighting factors are applied to each cracking type dependent on the failure mechanism. For example, alligator cracking has a higher weighting in the index as it is

considered to be the greatest factor to bring on rapid deterioration if not treated. Longitudinal and transverse cracking share the same, lesser weighting in the index as shown.

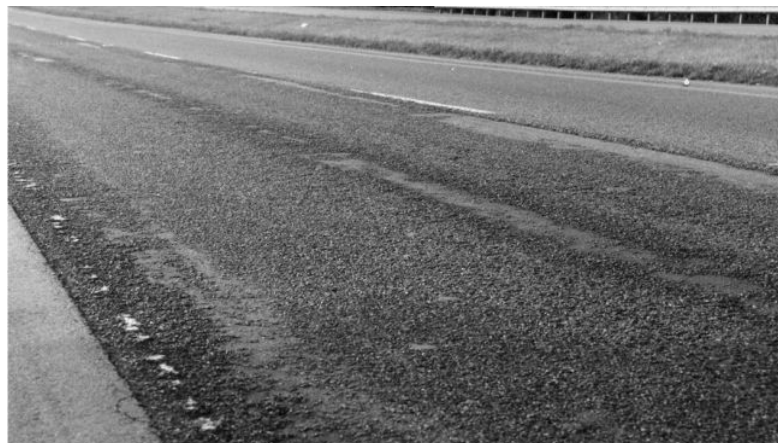
Ravelling is the disintegration of the pavement from the surface downward due to the loss of aggregate particles. Ravelling usually occurs as a result of the aging of the asphalt binder, but can also be attributed to poor mixture quality, segregation, or insufficient compaction during construction. A ravelled surface enables the ingress of water into the underlying pavement and, if left untreated, can lead to increased rates of pavement deterioration.

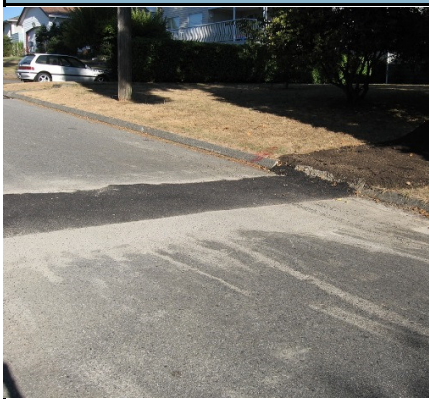
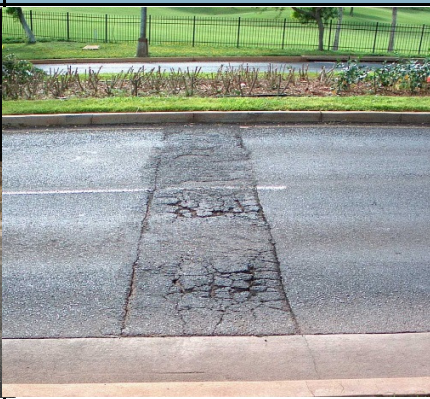
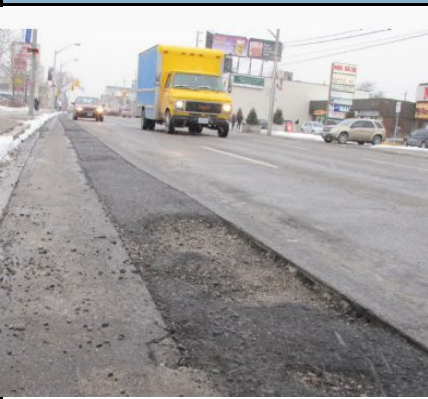
Low Severity Patching	Medium Severity Patching	High Severity Patching

Low severity patching has a condition range from brand new to slight aggregate loss and the opening of the sealed edges.	Medium severity patching has a condition range from slight aggregate loss and the opening of the sealed edges to cracking and aggregate loss throughout the patch, small depressions, and wider cracks at the edges.	High severity patching has a condition range from cracking and aggregate loss throughout the patch, small depressions, and wider cracks at the edges to aggregate loss that forms potholes, sinking and large depressions, and extensive higher severity cracking throughout.
