DISTRICT OF SOOKE WASTEWATER TREATMENT AND COLLECTION SYSTEM

OPERATED BY
EPCOR WATER SERVICES INC.

2008 ANNUAL REPORT

PERMIT NUMBER RE-17300

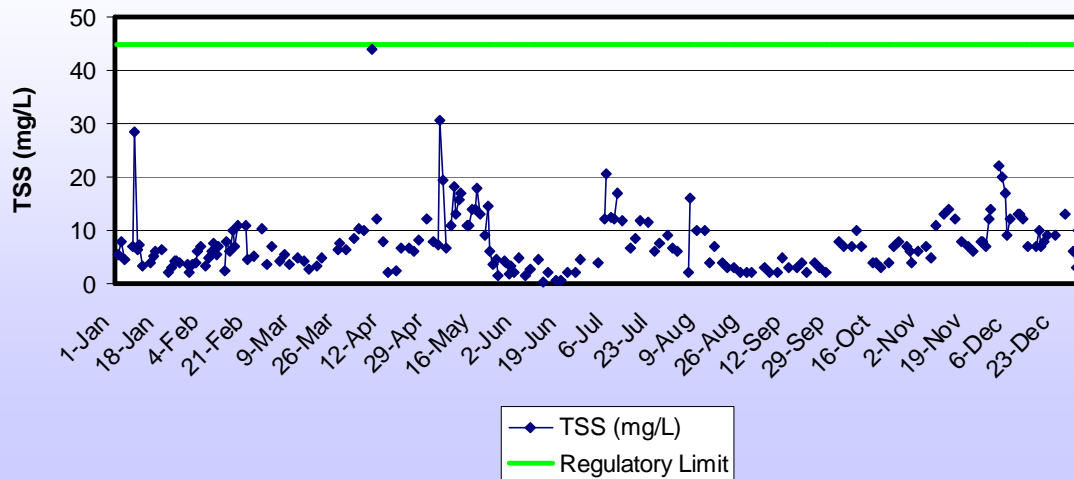
Sooke WWTP Effluent Quality - TSS

The following figures summarize the external lab test results for TSS, BOD and FC in the plant effluent through the year compared to the regulatory standards. The TSS, BOD and FC in the plant effluent were consistently better than the regulatory requirements throughout the year.

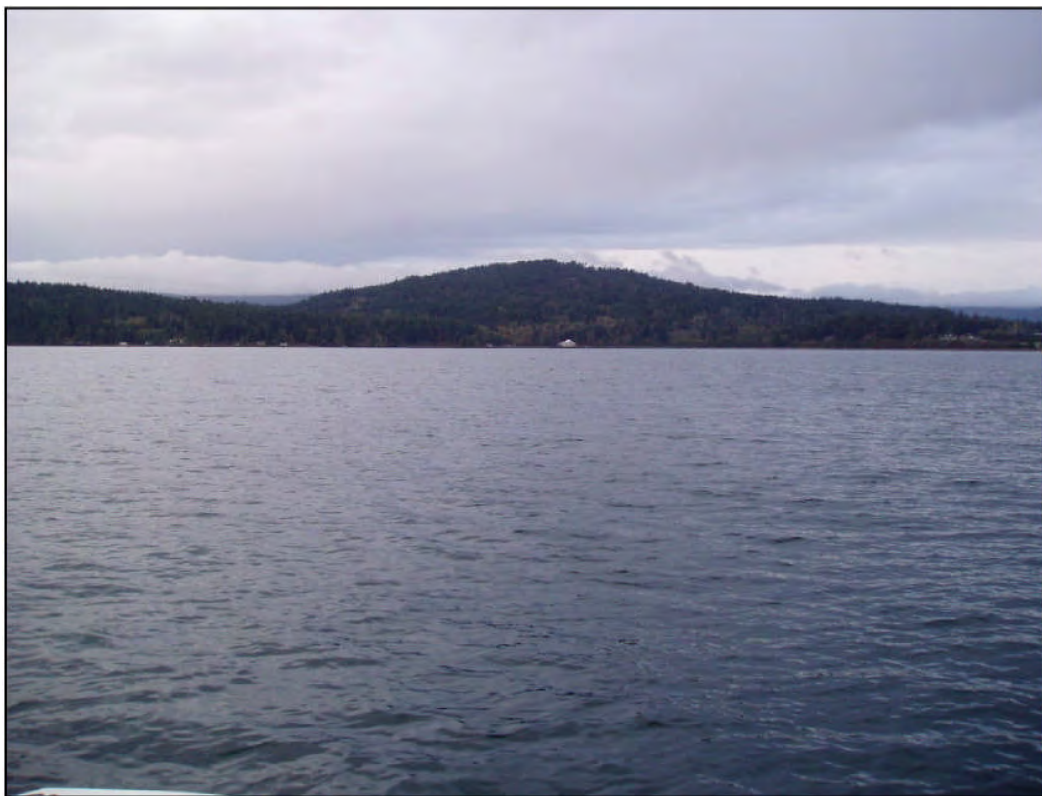
Photo 1: General location of sites 1 through 4

coliform, and total suspended solids. Photo 1 represents, in general, the areas designated for sites 1 through 4.

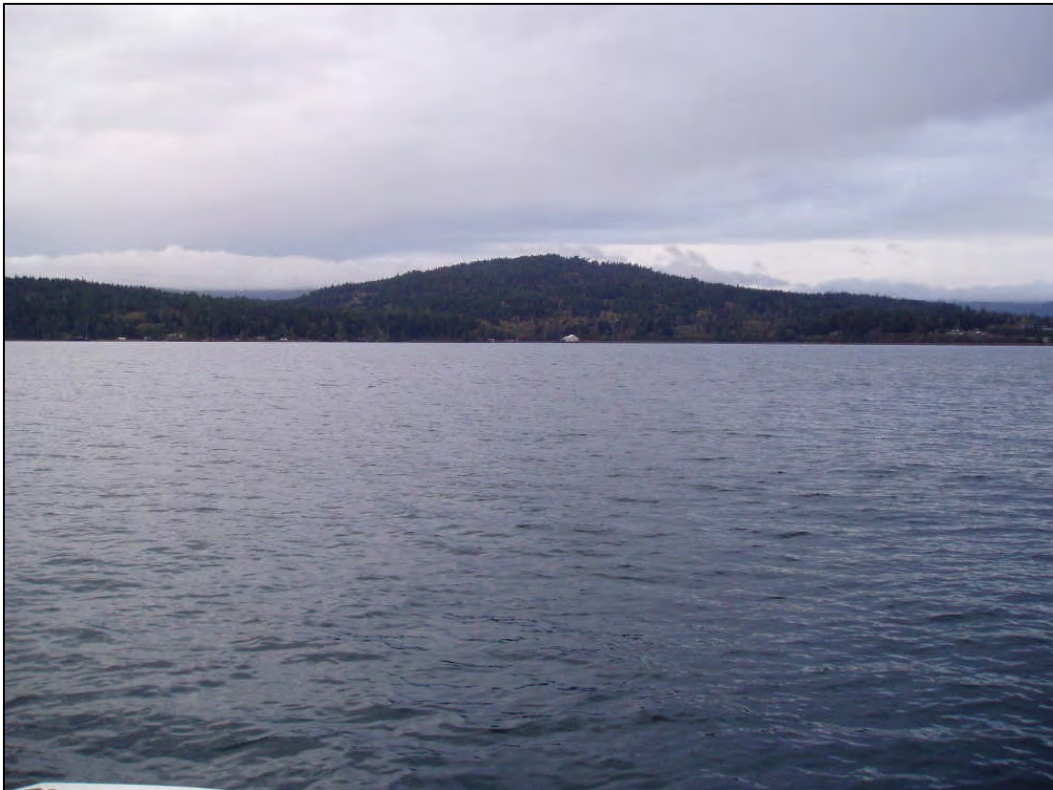
Photo 1: General location of sites 1 through 4

Specific results for each of the sites are listed in Table 1. The receiving waters surrounding the Sooke outfall contained acceptable levels of ammonia, BOD, fecal coliform, and total suspended solids. Photo 1 represents, in general, the areas designated for sites 1 through 4.

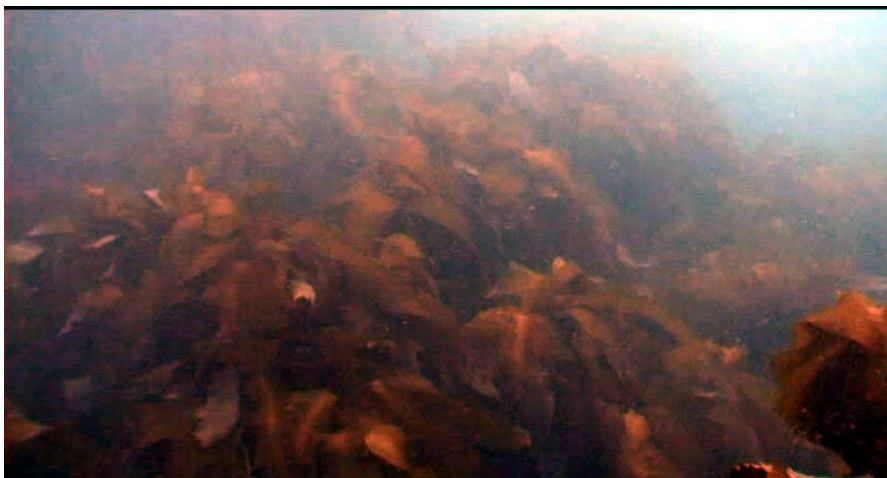
Jetting operations during construction impacted a corridor of kelp habitat approximately 4 m x 125 m through physical damage and substrate disturbance in the shallow subtidal zone above 10 m depth between Stations 0+45 to 4+50 (AMR 2005). A dense (over 100% cover at some locations) and diverse growth of vegetation has recolonized the outfall and formerly disturbed substrate areas in the shallow (< 10 m depth) subtidal zone (Photo 1) as was also observed during the 2006 monitoring survey. Canopy, stalked, and bladed kelps were observed growing on the pipeline including bull kelp (*Nereocystis luetkeana*), *Pterygophora californica*, *Laminaria sp.*, *Desmarestia sp.*, *Costaria costata* and *Cymathere triplicata*. Other vegetation including rainbow leaf (*Mazzaella splendens*), sea lettuce (*Ulva sp.*) and filamentous red algae have also colonized the outfall and formerly disturbed substrate areas.

Photo 1 – Dense *Pterygophora* stalked kelp growing on pipeline (beneath kelp).

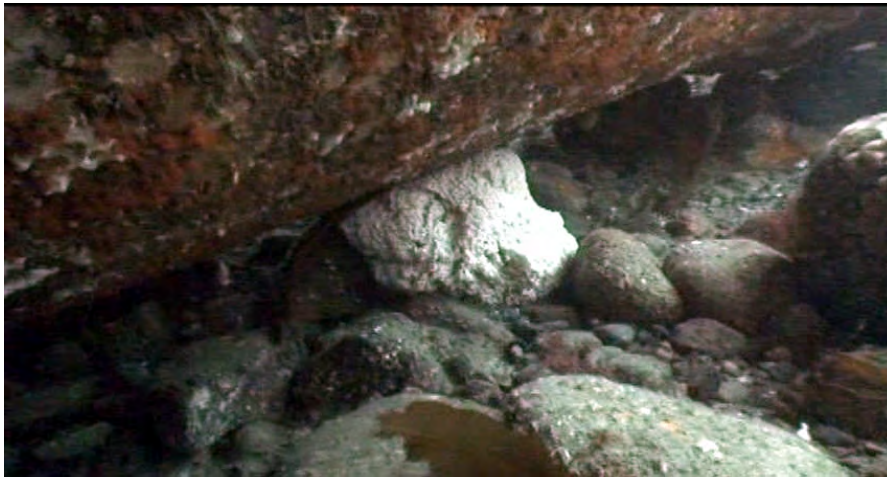
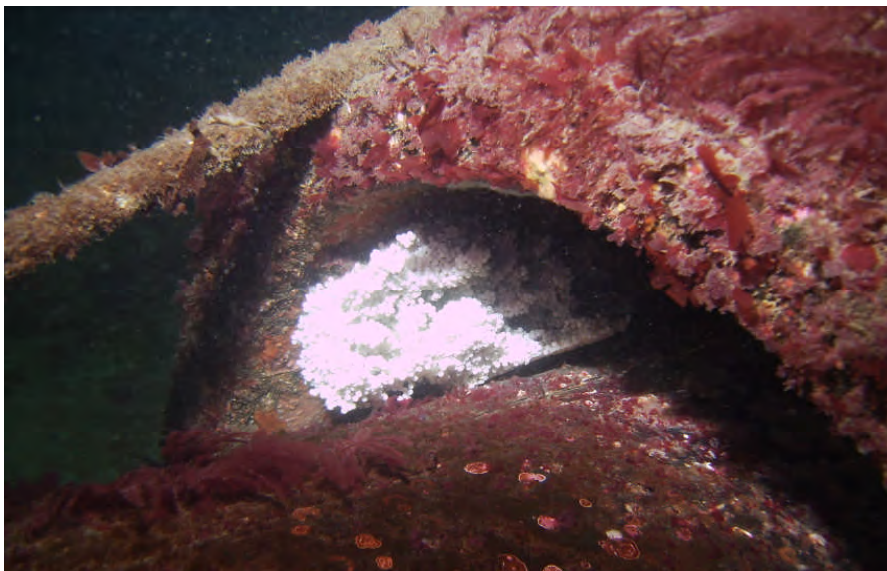
The outfall pipe, concrete cylinder weights, doghouse weights and articulated concrete ballast mats have added relief, complexity, and crevice space to the original habitat and were observed being used, nearshore and offshore, by a number of fish species including kelp greenling (*Hexagrammos decagrammus*), quillback rockfish (*Sebastes maliger*), copper rockfish (*Sebastes caurinus*) and lingcod (*Ophiodon elongatus*). The outfall structure is being used as spawning habitat by lingcod. A number of lingcod egg masses were observed within the cylinder weights and wedged under the pipeline at a variety of depths from approximately 10 m depth (kelp habitat) to depths of 25 m (Photos 3 and 4).

Photos 3 and 4 – Lingcod eggs beneath pipeline (near Station 3+00) and inside concrete cylinder weight (near Station 6+50).
