FINAL
Baseline Property Condition
Assessment with Specialist Reviews
of the Mechanical, Electrical, Fire and
Life Safety Systems

2205 Otter Point Road
Sooke, British Columbia

March 2, 2020

Pinchin File: 249997.000

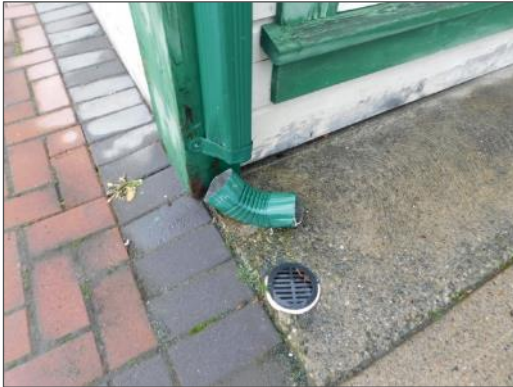
Detached downspout section was noted at the southwest corner of Site Building A.

<ul style="list-style-type: none"> Organic growth and the improper termination of downspouts were noted on the asphalt-shingled roof system atop Site Building A. 	<ul style="list-style-type: none"> Remove organic growth. Consideration should be given to extend the downspout into the lower eavestroughs to prevent accelerated deterioration of asphalt shingles at localized areas.
<ul style="list-style-type: none"> Detached downspout section was noted at the southwest corner of Site Building A. 	<ul style="list-style-type: none"> Re-secure downspout sections.
<ul style="list-style-type: none"> Eavestrough surrounding the asphalt-shingled roof system atop Site Building A were noted to be clogged with leaves and debris. 	<ul style="list-style-type: none"> Remove leaves and debris from eavestroughs.
<ul style="list-style-type: none"> Trees were noted to be encroaching onto the asphalt-shingled roof surfaces of Site Building A. 	<ul style="list-style-type: none"> Trees should be pruned to minimize the accumulation of leaves and organic debris build-up.

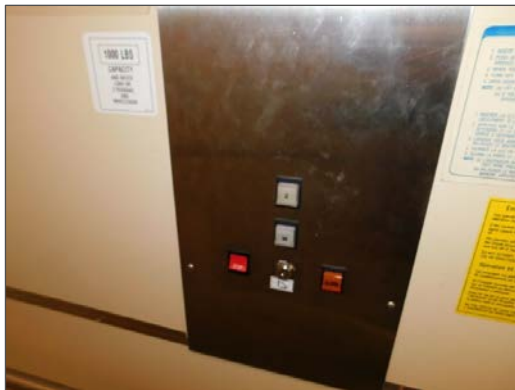
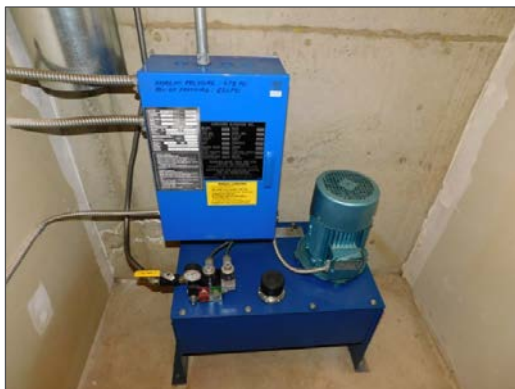
Table 3.7 – Elevator Systems	
Findings	Remarks/Recommendations
Major Deficiencies/Findings	
<ul style="list-style-type: none"> The elevator system serving Site Building A is original to construction (i.e., ~ 25 years old) with no major upgrade or modernization reported. 	<ul style="list-style-type: none"> Based on age, Pinchin recommends a specialist review of the elevator system within the early portion of the term of the analysis to assess modernization requirements.
Minor Deficiencies/Findings	
<ul style="list-style-type: none"> None observed/reported. 	<ul style="list-style-type: none"> None required.

General view of the control panel within the elevator cab serving Site Building A.

General view of the elevator machines serving Site Building A.

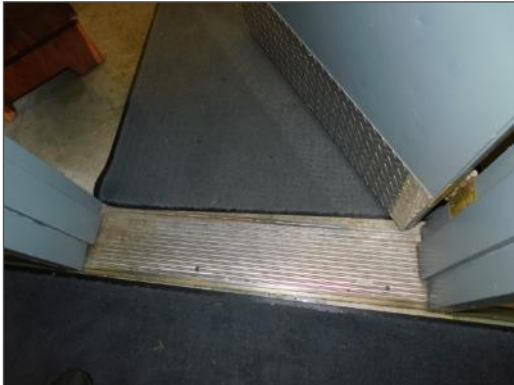
Lack of an air-tight seal was noted between the apparatus bay for fire trucks and other living areas within Site Building A.

Table 3.8 – Interior Finishes	
Findings	Remarks/Recommendations
Major Deficiencies/Findings	
<ul style="list-style-type: none"> Lack of an air-tight seal was noted between the apparatus bay for fire trucks and other living areas within Site Building A. 	<ul style="list-style-type: none"> Seal all openings and penetrations between the apparatus bay and other living areas to prevent a potential safety hazard.
Minor Deficiencies/Findings	
<ul style="list-style-type: none"> Various door handles were noted to be of residential grade and were of unsatisfactory condition. 	<ul style="list-style-type: none"> Replace door handles in unsatisfactory condition.
<ul style="list-style-type: none"> Localized cracks were noted on the flooring and concrete slabs within Site Building A. 	<ul style="list-style-type: none"> Conduct localized repairs as needed and monitor condition.
<ul style="list-style-type: none"> Incomplete finishing was noted within Site Building A due to reported repairs/inspection. 	<ul style="list-style-type: none"> Conduct repairs upon completion of the current repairs/inspection.

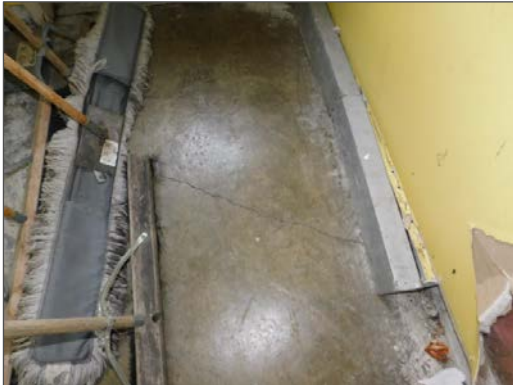
Localized cracks were noted on the concrete floor slabs within Site Building A.

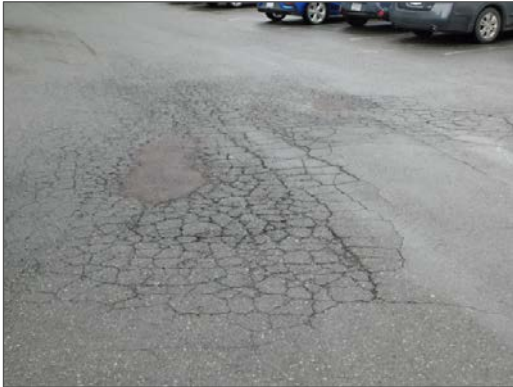
Cracking was noted at various locations of the asphalt pavement.

Note: Southeast entrance to the Site shown.

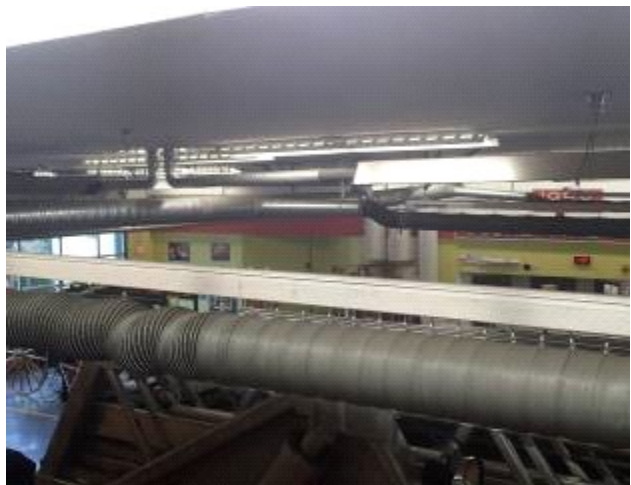
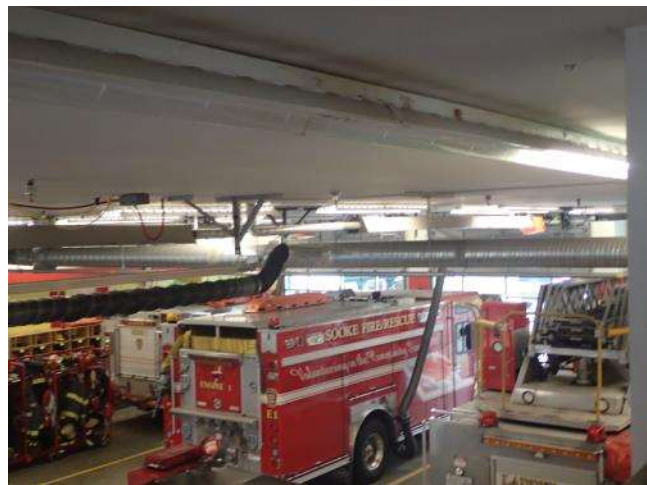
The apparatus floor currently has no makeup air system to replace exhausted air with warm air when the exhaust system is operational. While not required from a code or safety point of view, provision of a makeup air unit could be considered to improve occupant comfort in this space.

Figure 6: Fire Hall apparatus floor – vehicle exhaust ducting.

Figure 7: Fire Hall apparatus floor – vehicle exhaust ducting.

Fire Hall, Apparatus Floor Exhaust Ducting (Excluding Fan)	
Age of System/Equipment	12 years
Typical Service Life	20-25 years (ducting only, excluding fan)
Remaining Service Life	10-15 years
Replacement Cost	\$25,000
Recommended Replacement Timeframe	10-15 years
Recommended Upgrades/Repairs?	No. However, installation of a heated makeup air unit for operation during exhaust mode would improve comfort. This is considered optional.
Cost for Upgrades/Repairs	\$10,000
Recommended Upgrade Timeframe	5-10 years.
Consequences of not performing upgrade	Reduced occupant comfort.

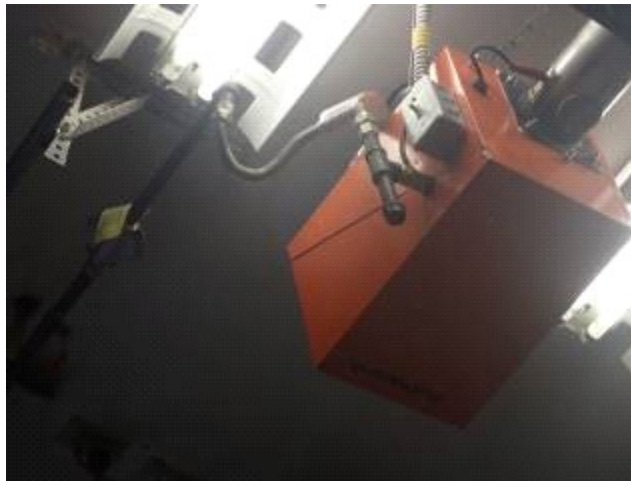
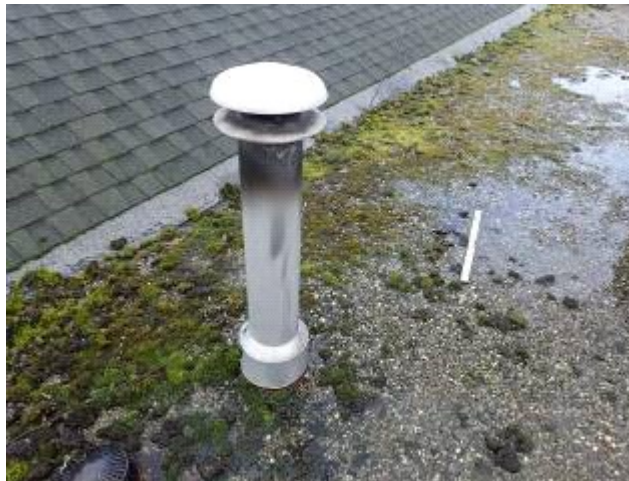
The overhead radiant heating system is original to the building, but was switched to natural gas supply (instead of propane) within approximately the last ten years. The system appears to be reasonably effective, but may be approaching the end of its useful service life. The system should be monitored for continued effective performance, including regular maintenance inspections.

Figure 10: Fire Hall apparatus floor – radiant tube heater.

Figure 11: Fire Hall apparatus floor – radiant heater roof vent.

Fire Hall, Apparatus Floor Heating System	
Age of System/Equipment	25 years
Typical Service Life	30 years
Remaining Service Life	5 years
Replacement Cost	\$15,000
Recommended Replacement Timeframe	5-10 years
Recommended Upgrades/Repairs?	No.
Cost for Upgrades/Repairs	\$0
Recommended Upgrade Timeframe	N/A
Consequences of not performing upgrade	N/A

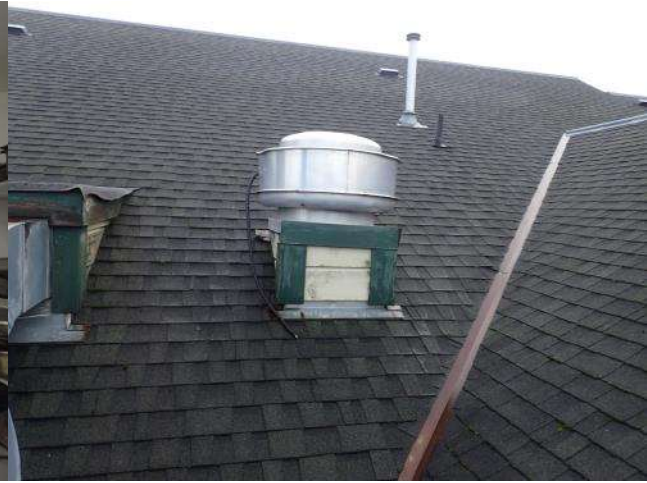
Figure 13: Fire Hall - Lounge kitchen exhaust fan.

No immediate issues were observed with the rooftop exhaust fan. However, this fan is likely approaching the end of its useful service life of 20-25 years. This provides additional rationale for replacing the existing exhaust ventilation system.

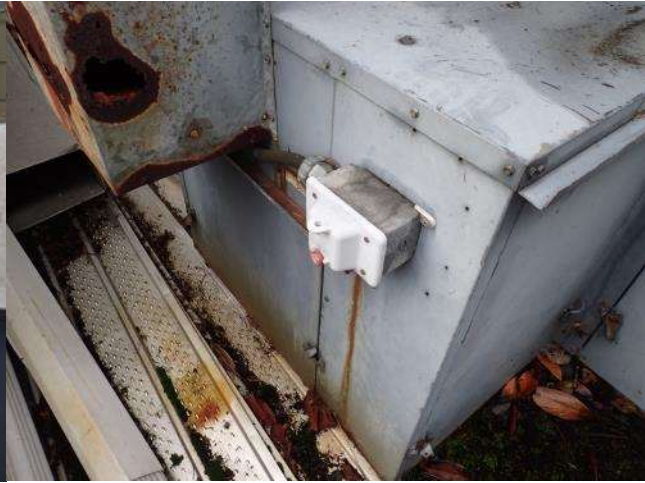
Figure 16: Municipal Hall – Abandoned makeup air unit.

This unit should be replaced, and the outdoor air supply ducting to the offices should be reconfigured to supply outdoor air to each of the individual office spaces as required by ASHRAE 62.1. Given that the washroom exhaust fan for the downstairs offices is located adjacent to the makeup air unit, there appears to be scope for installing a heat recovery ventilator (HRV) which would reduce energy consumption in heating/cooling the outdoor air supplied to the building.

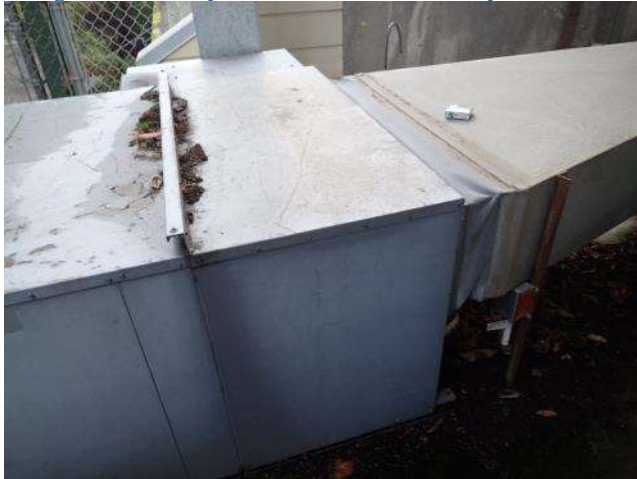
Figure 17: Municipal Hall – Abandoned makeup air unit.

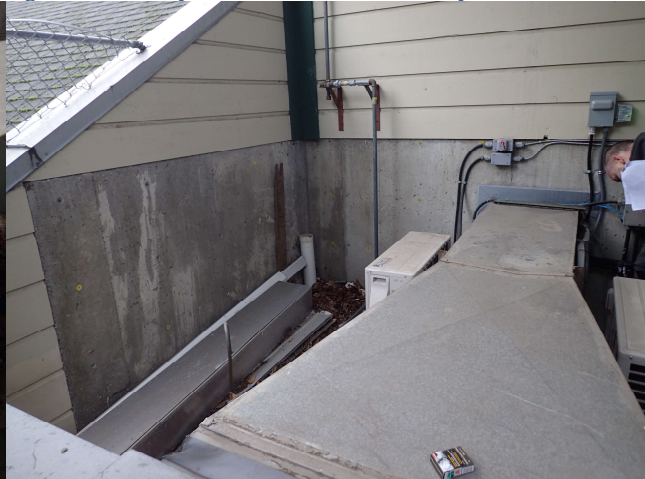
Figure 18: Municipal Hall – Makeup air duct.

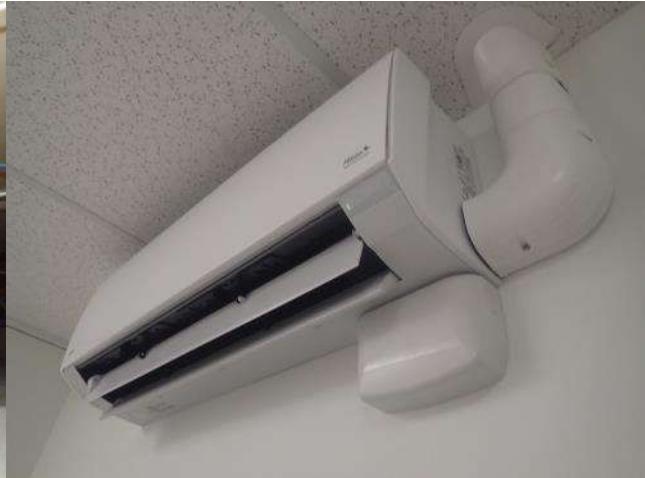
Figure 22: Municipal Hall - Typical wall-mounted split system, indoor unit (new).

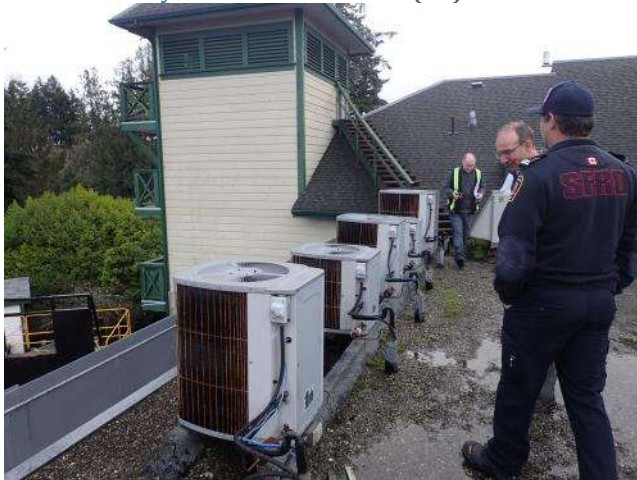
Of the original split systems left in place, it is apparent that they are aged beyond their expected service life of 15 years. The outdoor condensing units exhibit signs of corrosion and wear, with exposed refrigerant lines (worn insulation) and non-functional local disconnect switches. Wherever the original systems are still operating, it would appear that these should be replaced as soon as practical.

Figure 23: Municipal Hall - Some condensing units for older split systems are on fire hall roof.

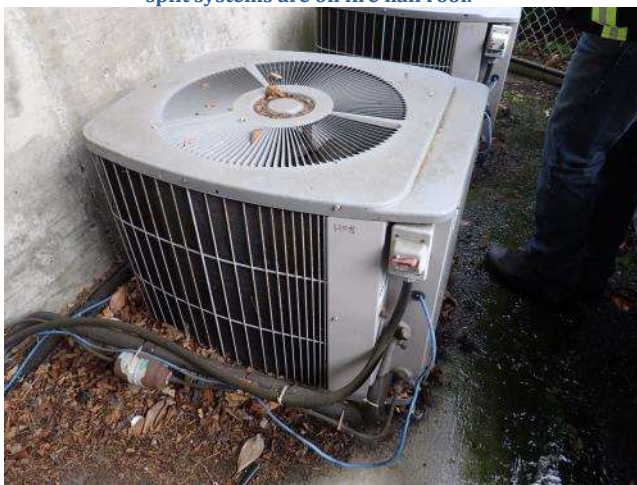
Figure 25: Municipal Hall - Additional condensing units, located adjacent to makeup air unit.

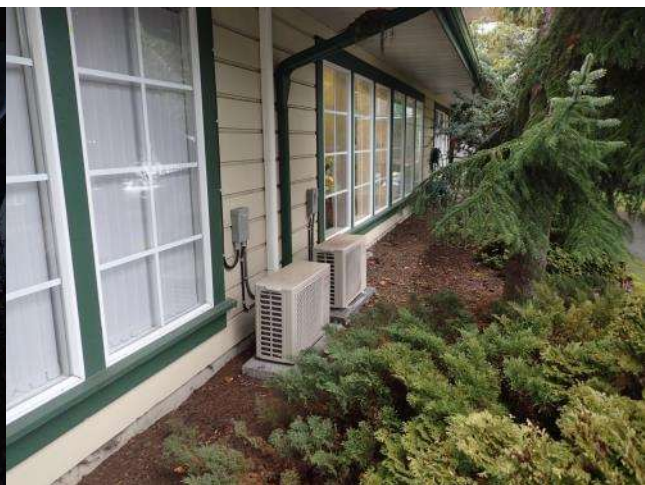
Figure 26: Municipal Hall - New condensing units.

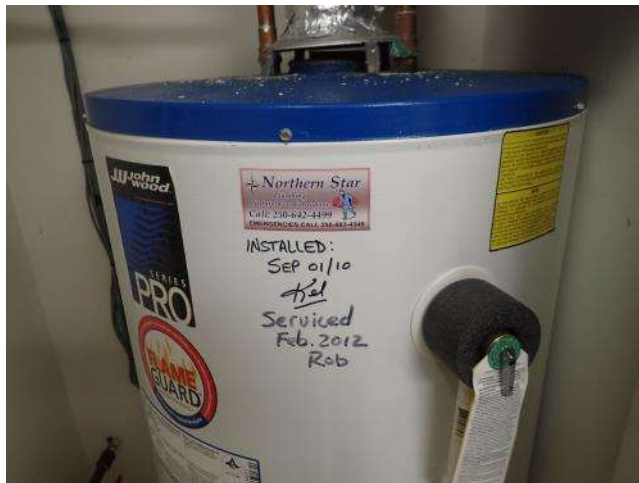
The John Wood 3 kW electric water heater serving the Municipal Hall was installed in 2012 (based on the serial number). The John Wood natural gas water heater serving the Fire Hall was installed in September 2010. No operational issues were observed or reported, and it is expected that these water heaters should have approximately 5-10 more years of useful service life remaining.

Figure 27: Fire Hall – Domestic hot water tank.

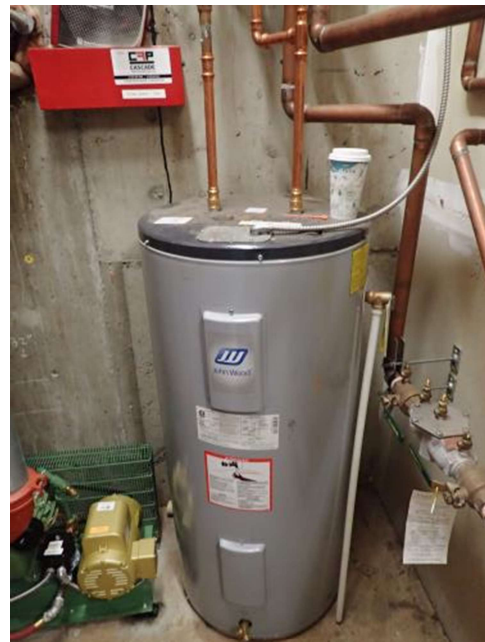
Figure 28: Municipal Hall – Domestic hot water tank.

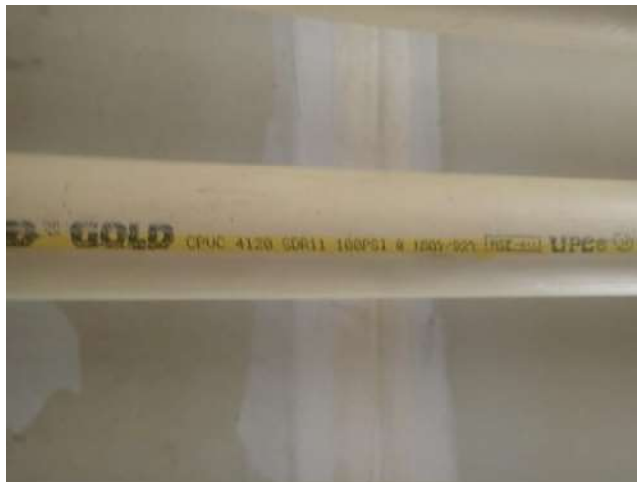
Much of the interior piping is cPVC, and this piping has failed in a number of locations (four failures in the past 6 months), causing substantial water damage and repair costs. This type of piping is notorious for premature piping failures. The fact that piping has failed in a couple of locations already is a reasonable indication that the entire cPVC domestic water piping distribution system is now degraded beyond its useful life. To prevent future leaks, all remaining cPVC piping should be removed and replaced with more resilient piping materials. We understand that the underground piping is PEX, so it is likely that only the above ground piping in the walls and ceiling needs to be considered in this case. This should be confirmed as part of any upgrade project.

Figure 29: cPVC piping, typical of domestic water distribution piping throughout building.

Domestic Water Piping Systems	
Age of System/Equipment	25 years
Typical Service Life	Variable for cPVC
Remaining Service Life	0 years
Replacement Cost	\$100,000
Recommended Replacement Timeframe	Immediately
Recommended Upgrades/Repairs?	Yes – Detailed inspection and testing may allow life extension.
Cost for Upgrades/Repairs	\$0
Recommended Upgrade Timeframe	N/A
Consequences of not performing replacement	Costly water damage due to failed pipes.

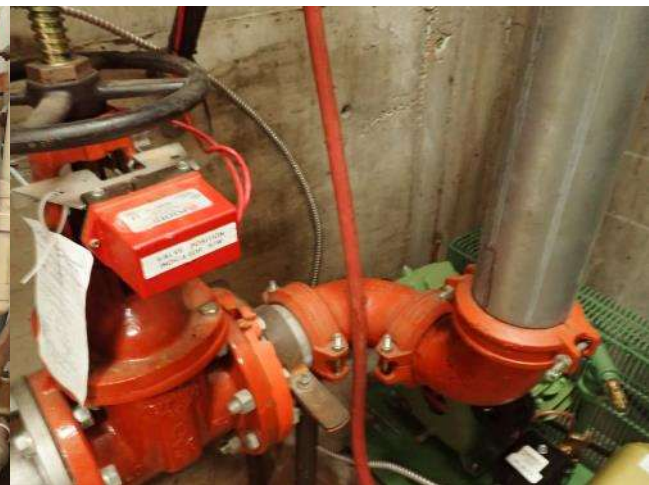
Figure 32: Sprinkler system - valve with recent test tag.

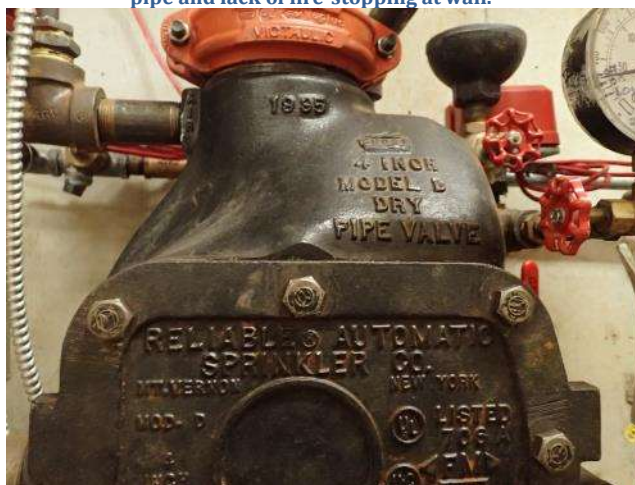
Figure 33: Sprinkler system dry pipe valve.

We recommend that the fire sprinkler system be upgraded as soon as possible to bring the system in compliance with NFPA. In order to complete this work, we recommend the following:

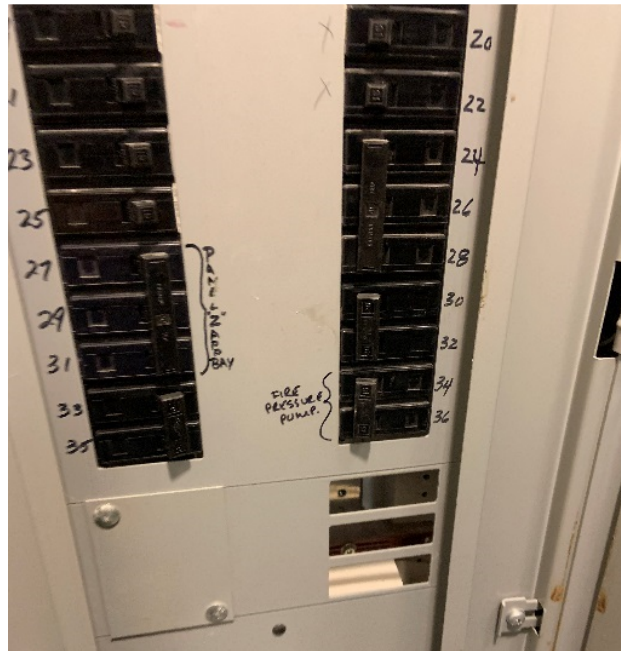
Emergency Panel X 400 A sub feeds Panel Z in the apparatus Bay and Panel Y in the Fireman's Lounge. Panel X is full. Panel X has missing filler plates which means that live bussing is exposed when the panel door is opened presenting a safety risk.

Install filler plates on Panel X. Install new emergency power 42 circuit minimum (60 cts preferred) sub panel near panel X and transfer some of the circuits.

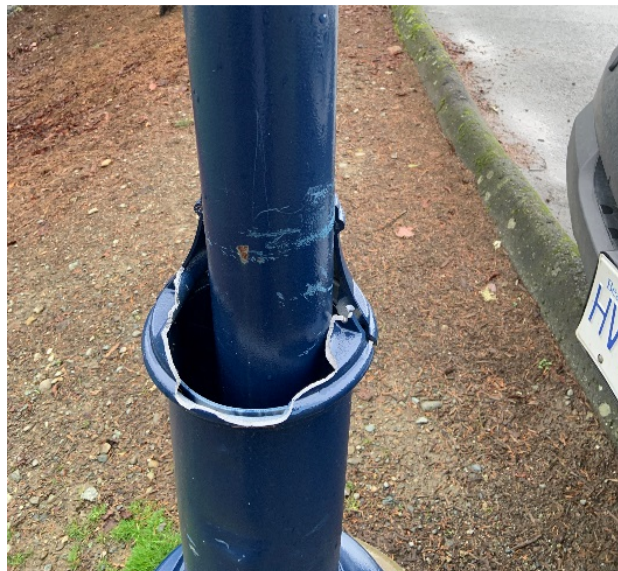
Some of the retrofitted clam bases have sustained vehicle damage and the remaining locations are subject to damage when vehicles back into stalls.

Replaced damaged clam shell bases on lower parking lot pole lights. Installation of additional wheel stops and small car only signage where poles are located close to parking stalls may prevent further damage. Alternatively relocate pole and pole base 1.0 m from curb. Site grading may make this prohibitive.

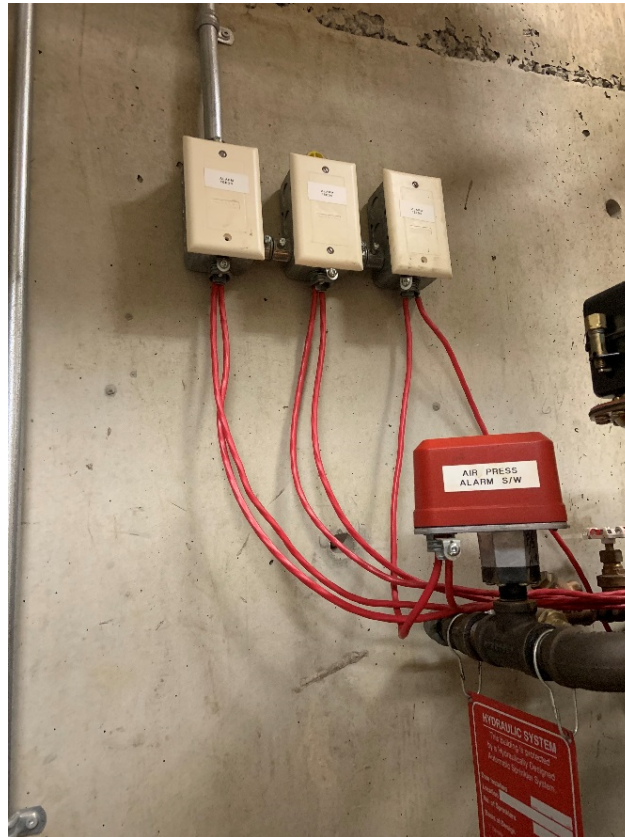
The Fire alarm wiring to sprinkler tree is free air in un-armoured cable so does not meet Canadian Electrical Code. Power to the compressor is not monitored, low air is.

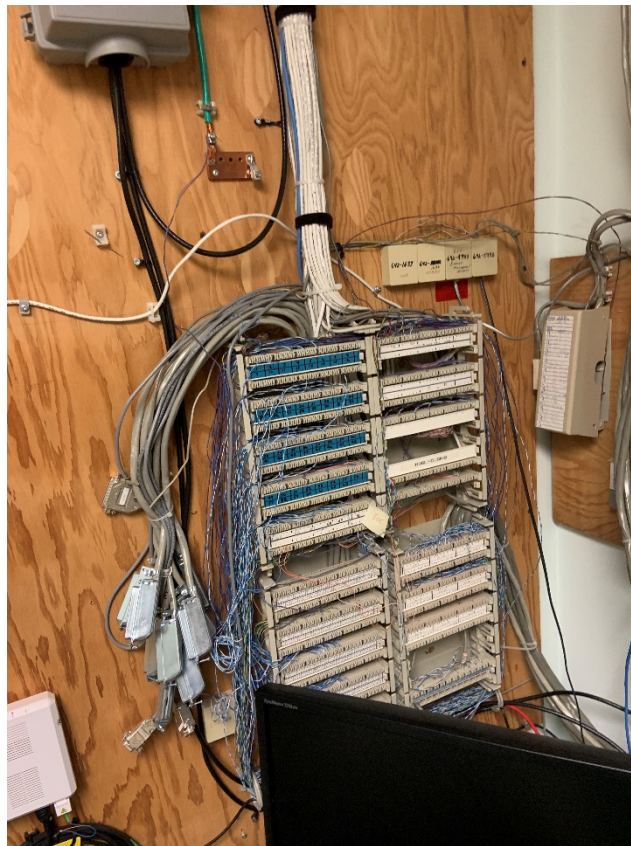
Structured Cabling is combination of majority Cat 5e and some Cat 6. Horizontal data cabling is brought back to a local patch panel where it is then connected. There is small wall mounted rack located in the emergency Call Centre Room Use of data seems to be confined to administration areas and the central staffed areas. Use of a single telecom rack or room to provide services to multiple floors does not meet TIA/EIA standards. A dedicated server or telecom room doesn't exist for this facility as racks are collocated with electrical panels in a combine room. The room does have access control to monitor entry. Telecom room size is quite cramped. Switches present on site are Cisco 48 port.

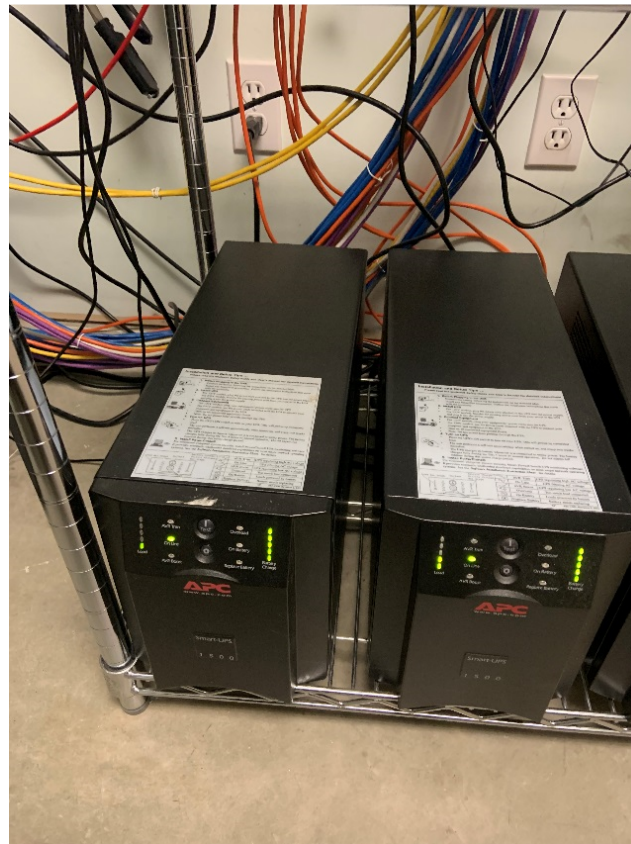
Equipment is backed up by local APC Uninterruptable Power Systems (UPS). Power for appears to be on normal power so not backed up by generator.

Emergency power panel fed from local transfer may not start the emergency generator in case of normal power feed from exterior electrical room failing. This could result in parts of the facility being without emergency power.

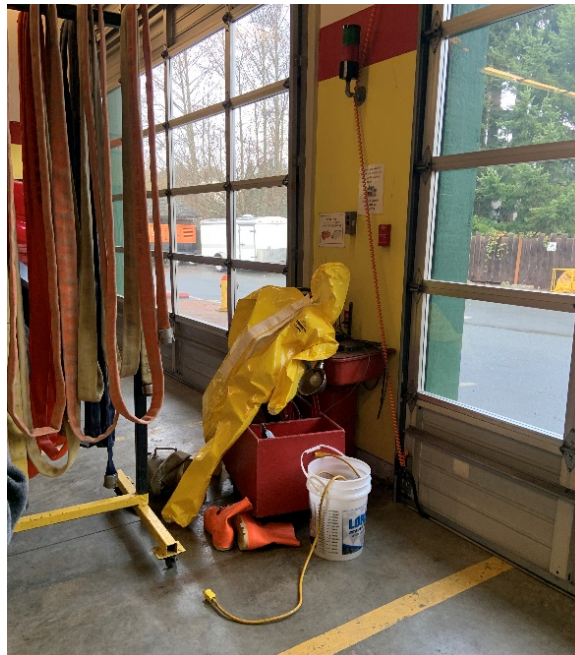
Overhead doors are electrically operated and are reportedly backed up by the emergency generator. The doors have indicator lights adjacent to the door to provide indication to the apparatus drivers that the door is fully opened. It was noted that the door closest to the ham radio room the light was not functioning correctly.

Ensure all door indication lights are operational and all lamps working.

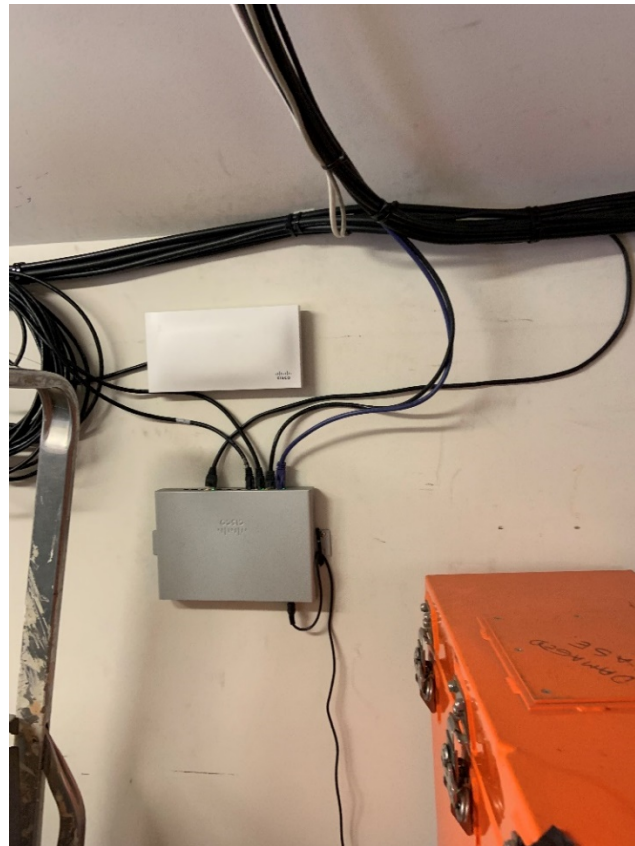
The BC Ambulance Service (BCAS) has equipment in a locked cabinet on the mezzanine. Personnel on site do not access this equipment and this equipment is maintained by BC Ambulance service. This equipment was not evaluated as part of this report. Cable management on the mezzanine could be improved.

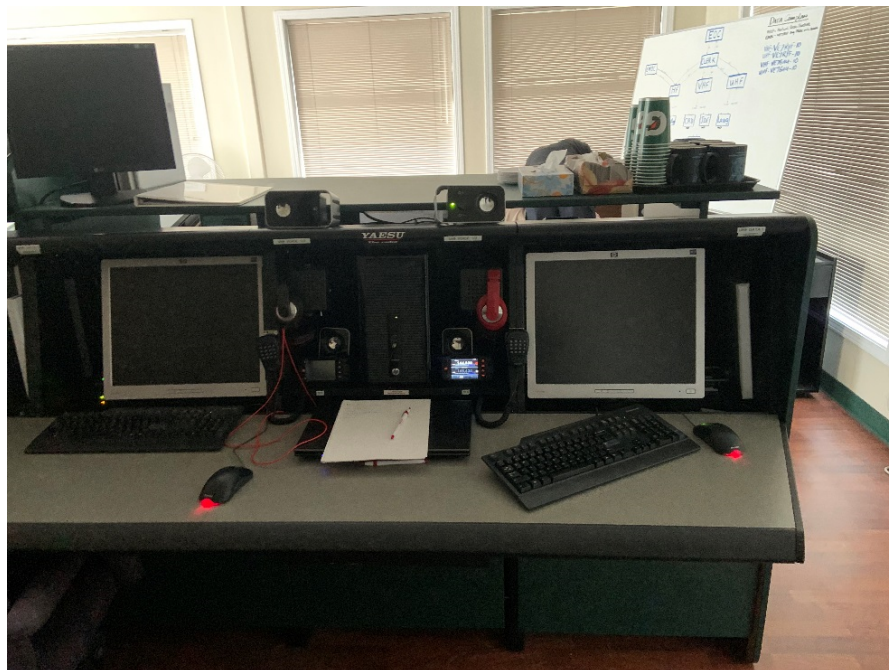
15 HAM RADIO - BC AMBULANCE

An exterior accessible room used by the local Ham Radio organization is adjacent the apparatus bay and contains equipment used by the organization and some BC Ambulance equipment although this is not staffed by the BCAS. Electrical installation appears adequate and code compliant and follows the standard of installation in the rest of the building.

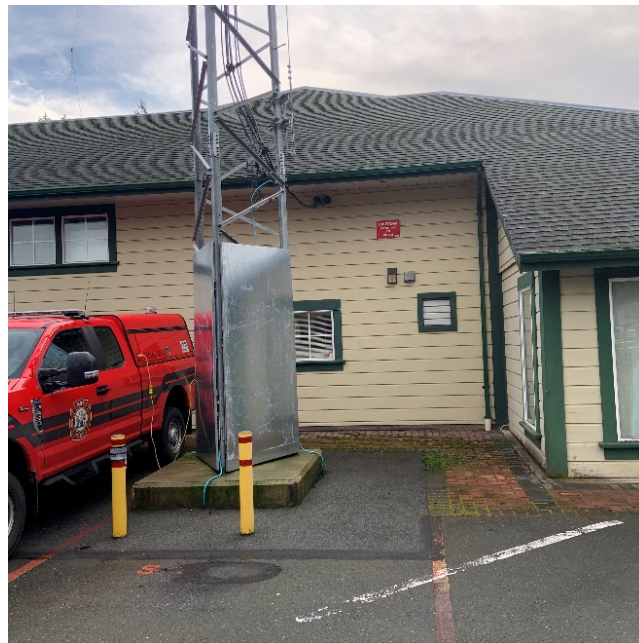
16 RADIO TOWER AND TRAINING TOWER

The radio mast has been relocated from original roof mounted location to ground mounted location adjacent the apparatus bay. Bonding and mechanical protection for the mast appears adequate and in compliance with the CEC. Cable management from the mast to the Building could be improved.

Training tower is attached to the main building and is used for fire fighter training purposes and to access the HVAC enclosure on the roof. The tower contains lights at landings with no fire detectors. Some lights are damaged and missing bulbs. The electrical installation is consistent with the remainder of the building.

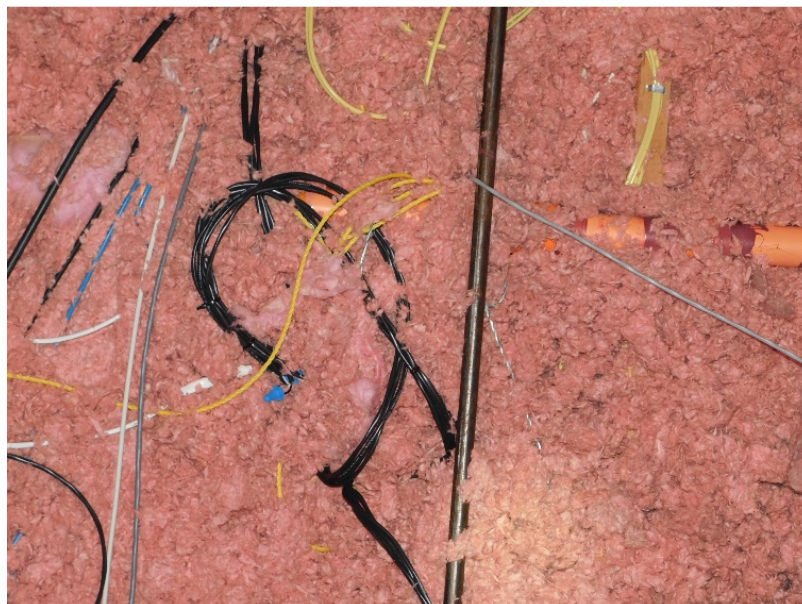
The upper soffit space contains cable terminated in marrets (wire nuts) laying loose on the insulation. This cable should be traced out and terminated in a junction box that is labeled as to function. There is also NMD90 wiring strapped to the top joists where it could be subject to mechanical damage. This wiring should be protected or re-wired in AC90 (BX).

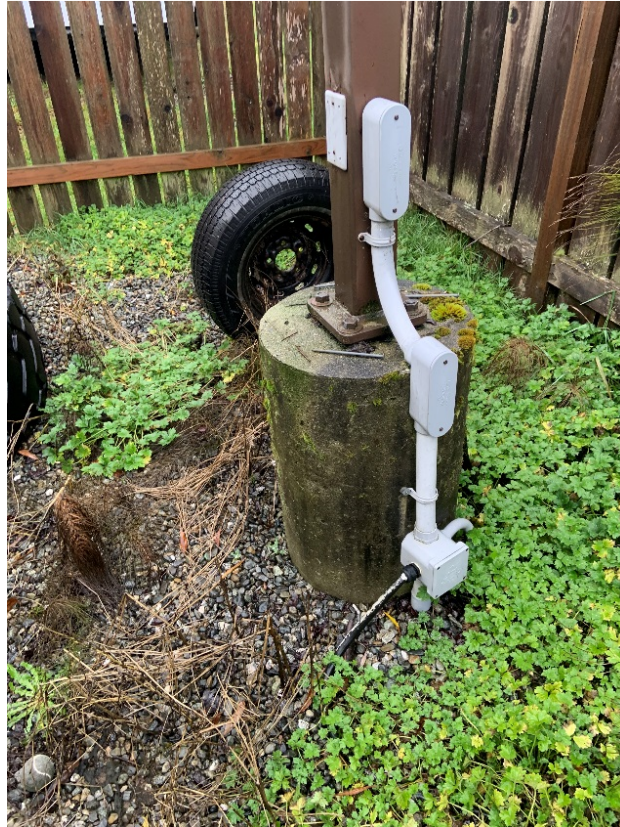
The Television feed to the gym appears to share a common conduit with the power feed into the single phase panel. This installation is not compliant with the CEC as only control wire is allowed to share the raceway system with power wiring.

Power to feed the weight room is run through the pole lighting conduit system then underground to the panel. If the exterior lights power is fed from the emergency generator circuit running the weight room normal power feed in the same conduit system to the weight room would constitute a CEC violation.
